Významné výpadky v kontinentálnej Európe v roku 2021

Ing. Stanislav Prieložný

SEPS, a.s.

Poráč 3.11.2022

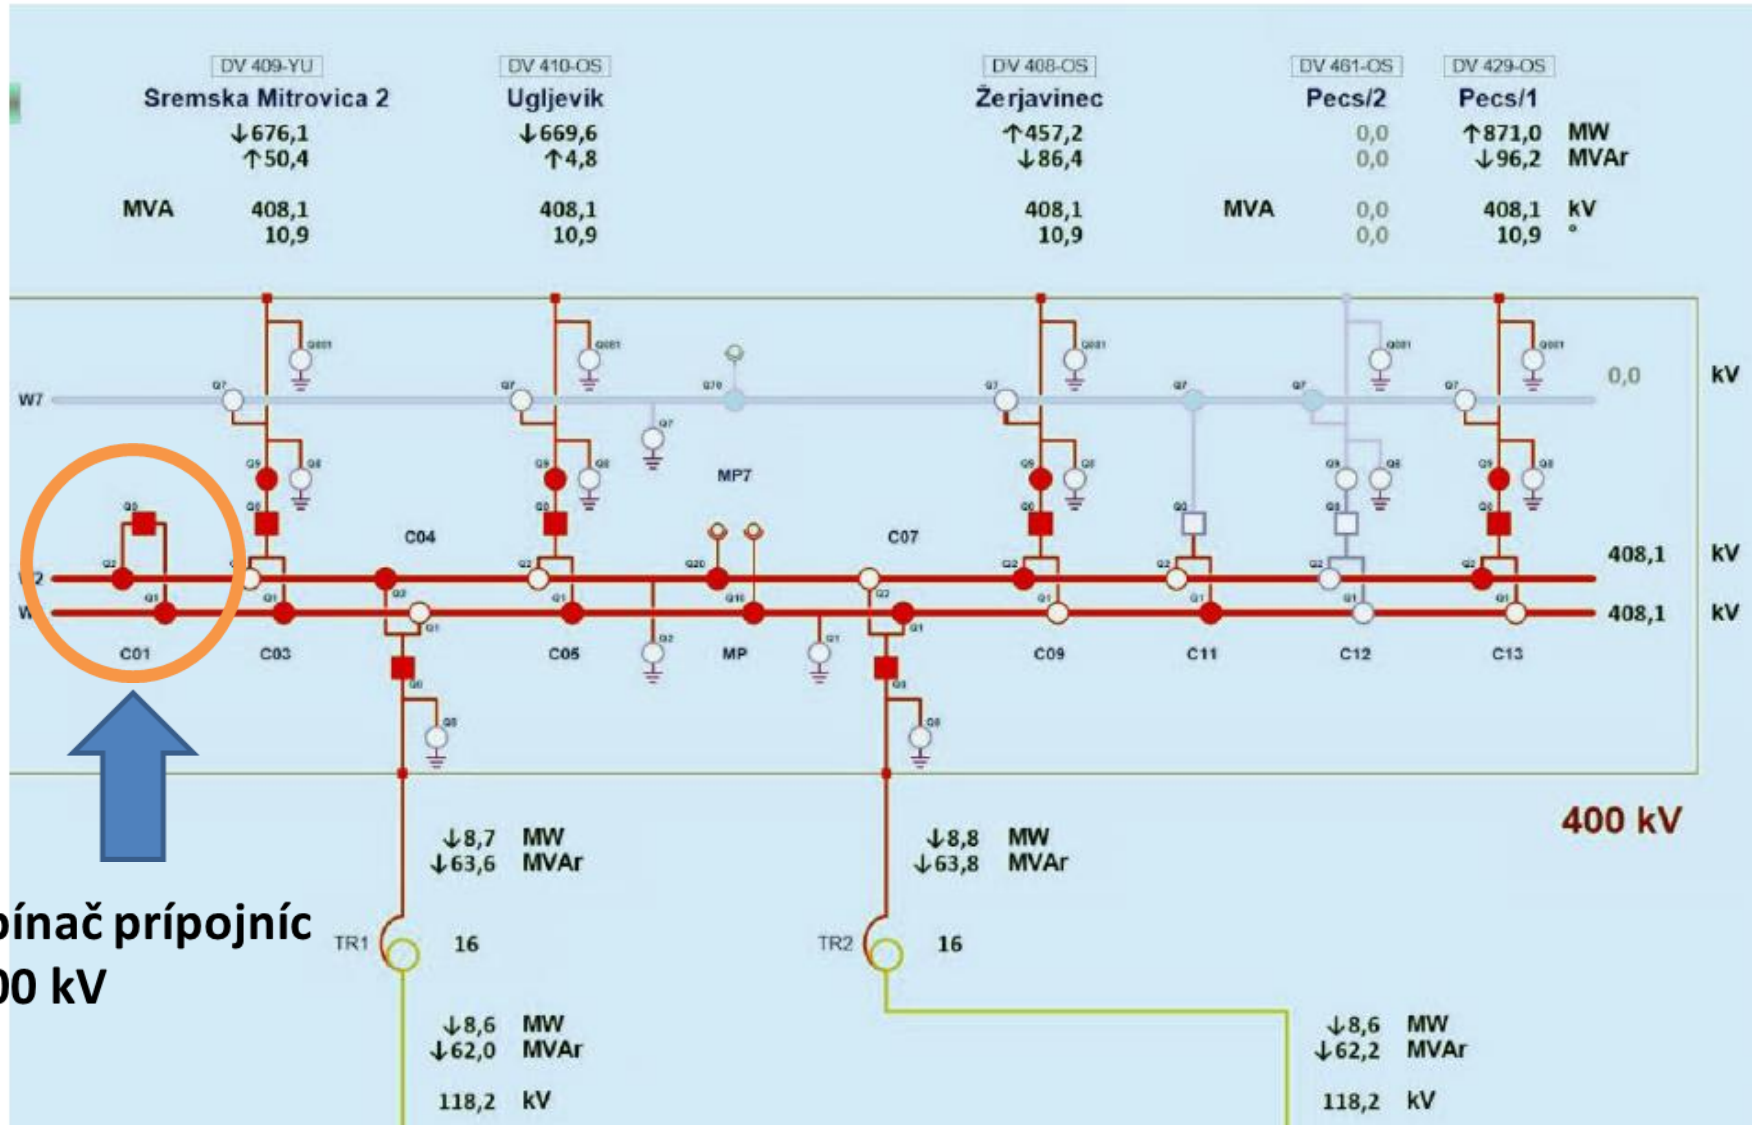
Rozvodňa 400 kV Ernestinovo

- W1 & W2 - main busbars
- W7 - auxiliary busbar
- - disconnector switched off
- - disconnector switched on
- - circuit breaker switched off
- - circuit breaker switched on

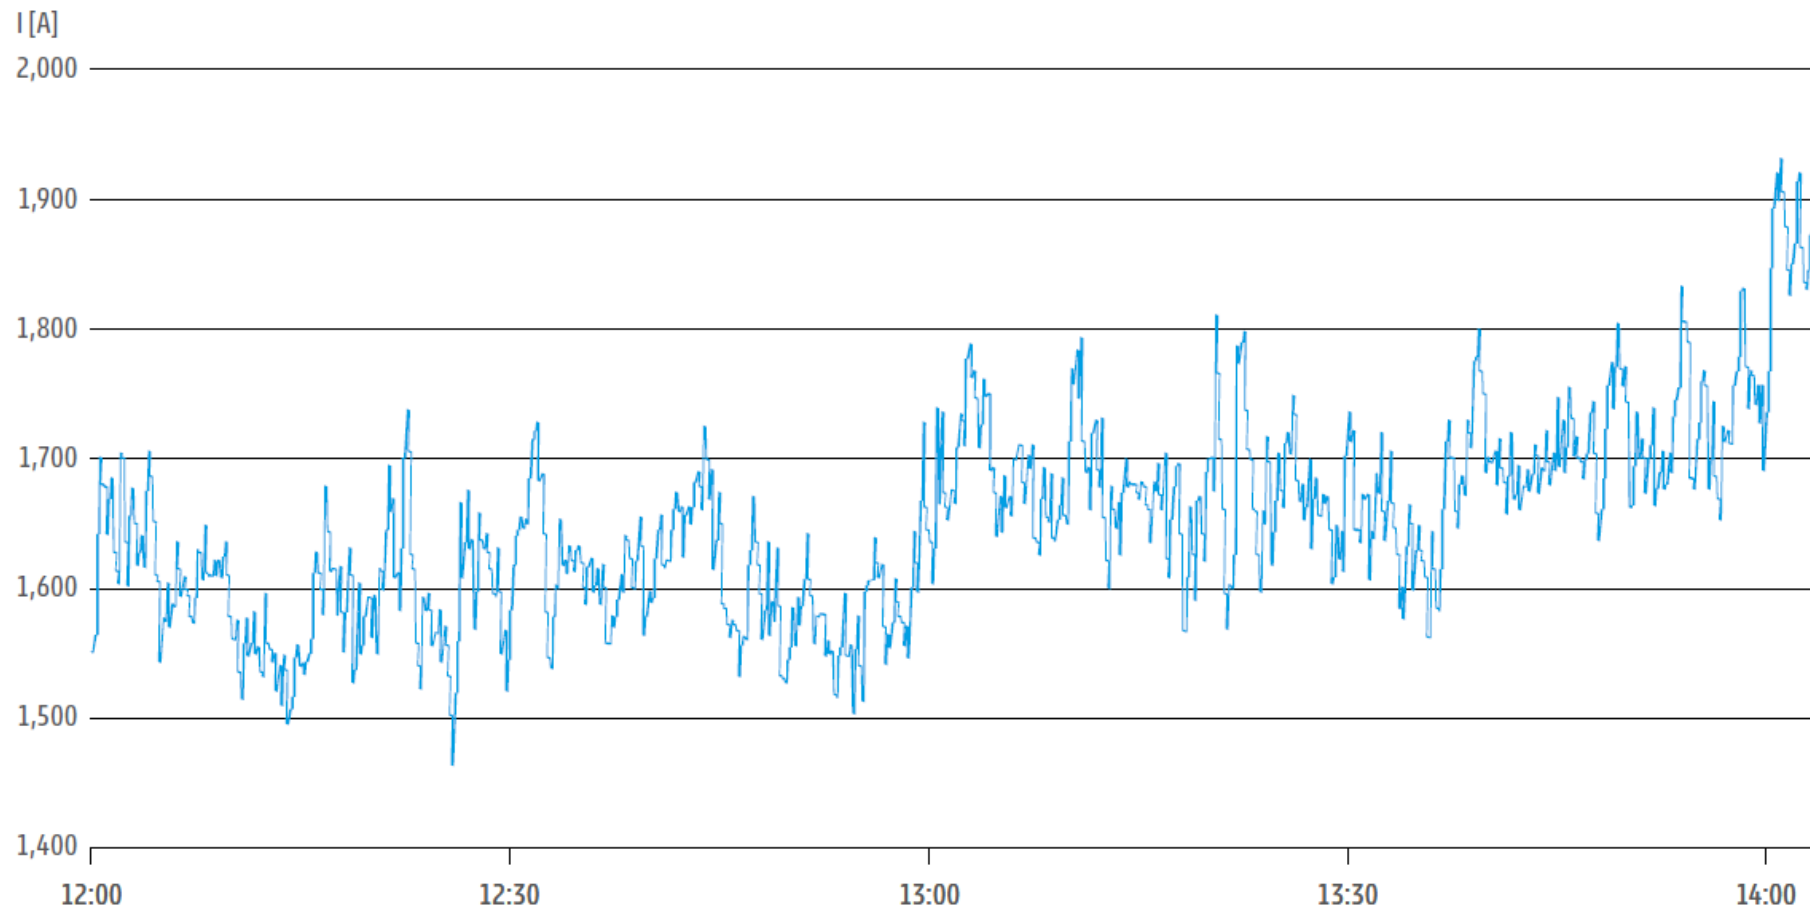
Prúdy na spínači prípojnic 400 kV Ernestinovo

busbar coupler 400 kV Ernestinovo • 08 January 2021 • 12:00:00 - 14:04:26

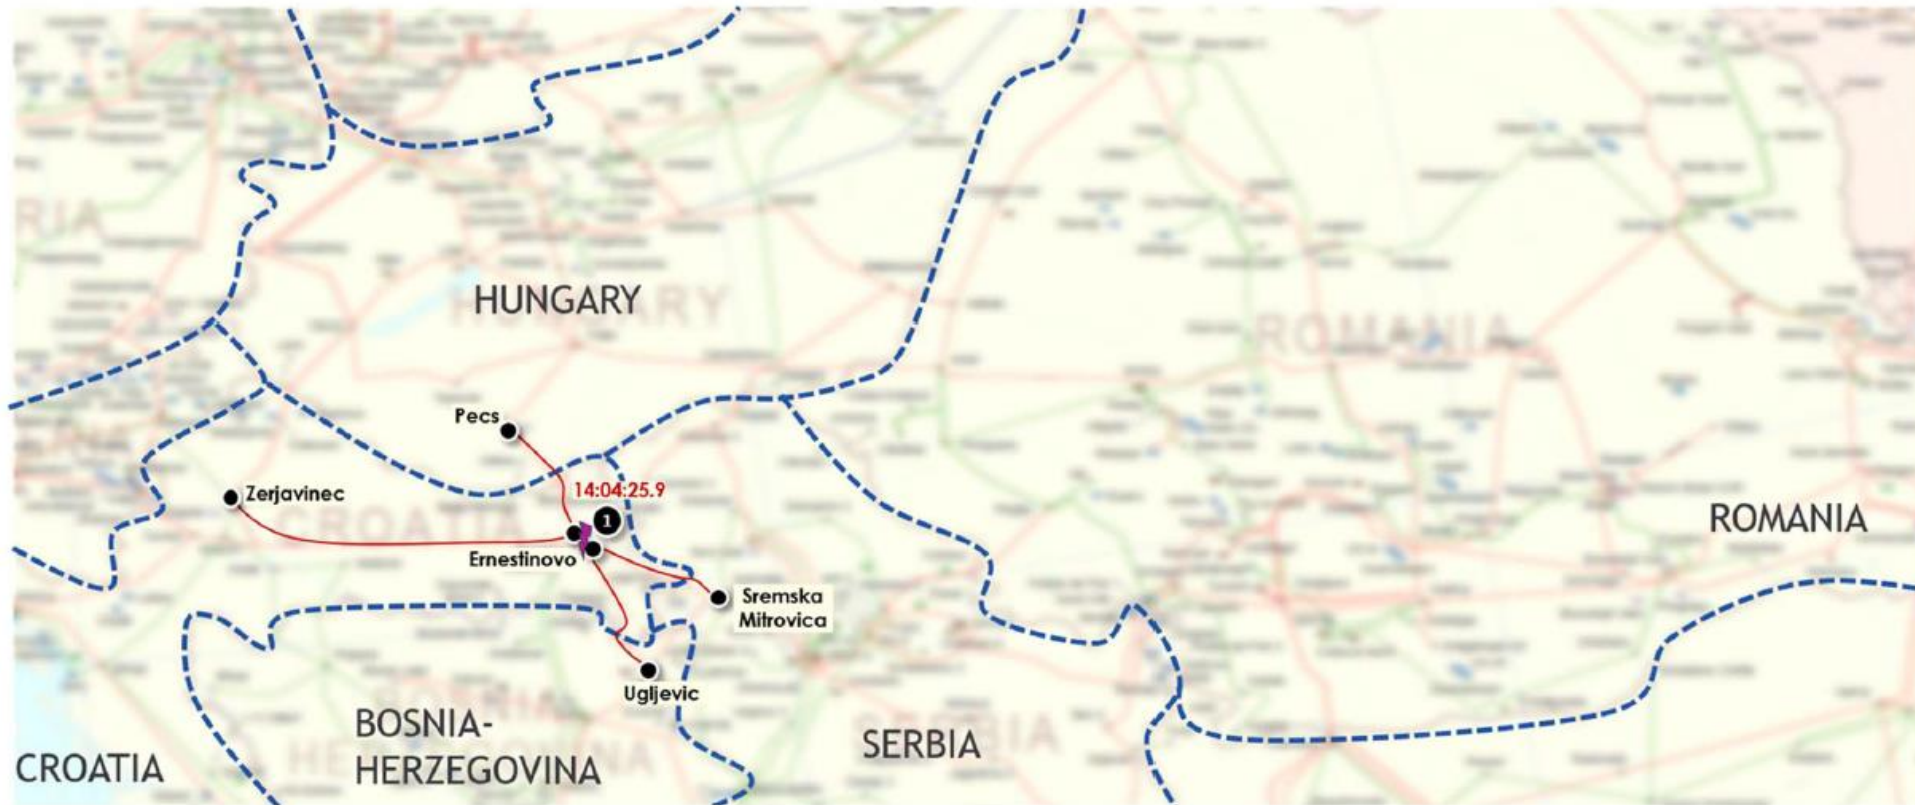
Inicializačnou udalosťou bolo vypnutie spínača prípojnic 400 kV v Rz Ernestinovo nadprúdovou ochranou o 14:04:25

Rozdelenie prevádzky v Rz 400 kV Ernestinovo na dve prípojnice viedlo k rozdeleniu sústavy CE

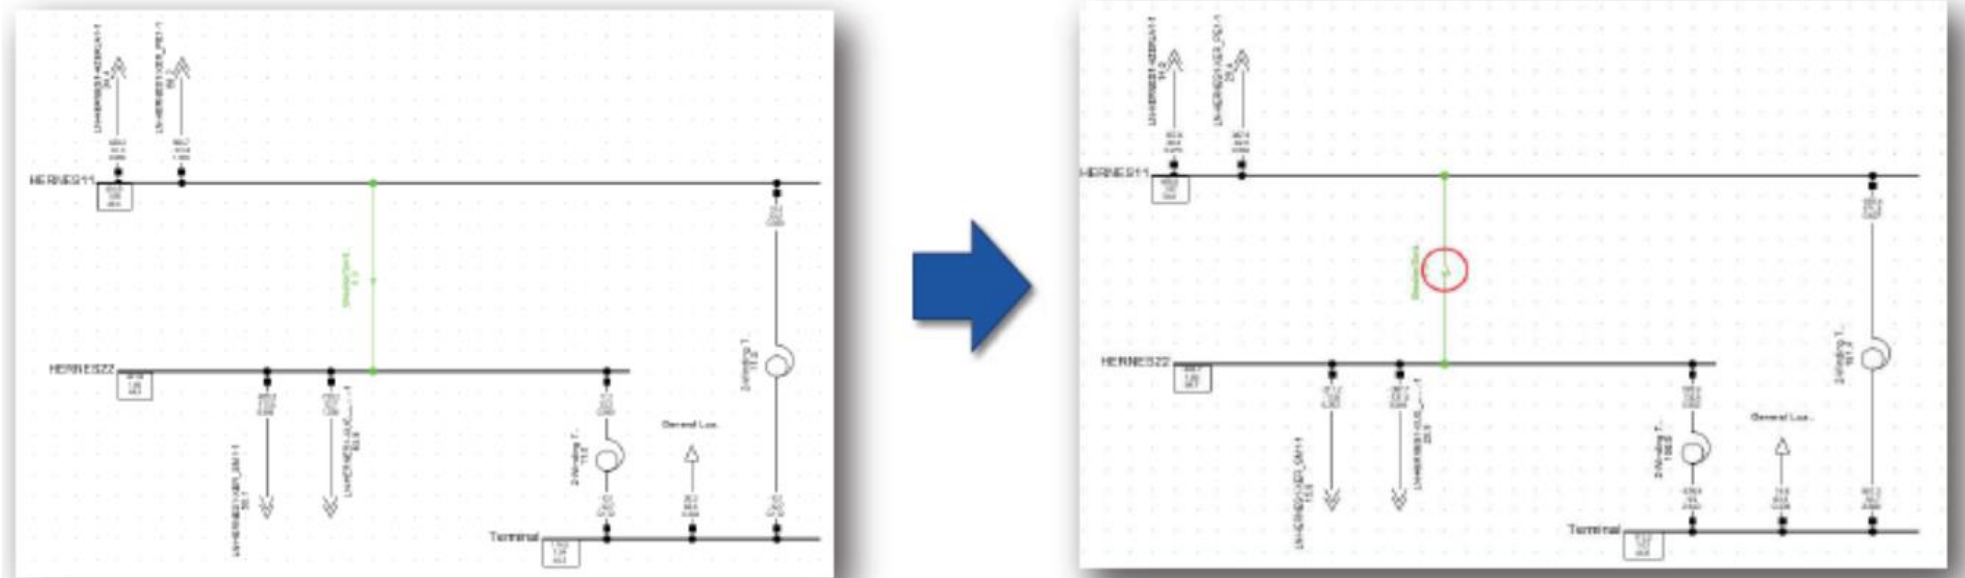
Prvá udalosť: vypnutie spínača prípojnic 400 kV Ernestinovo

Vypnutie spínača prípojnic 400 kV Ernestinovo spôsobilo presun tokov na transformátory v Rz Ernestinovo

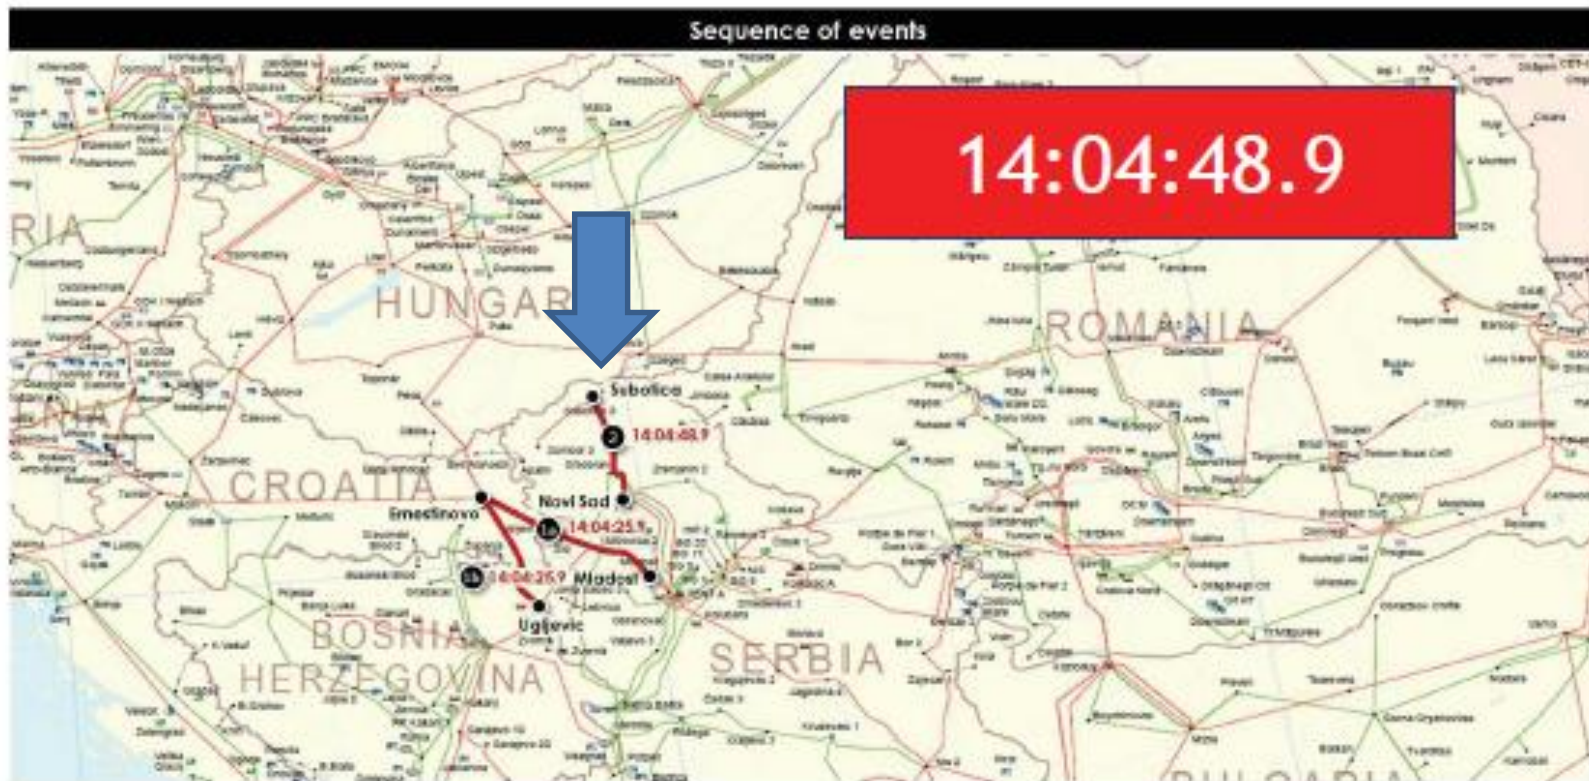
Druhá udalosť: vypnutie vedenia 400 kV Novi Sad - Subotica

Situácia v sústave sa dostala do nezvratného stavu a nestability a nasledovala kaskáda ďalších vypnutí

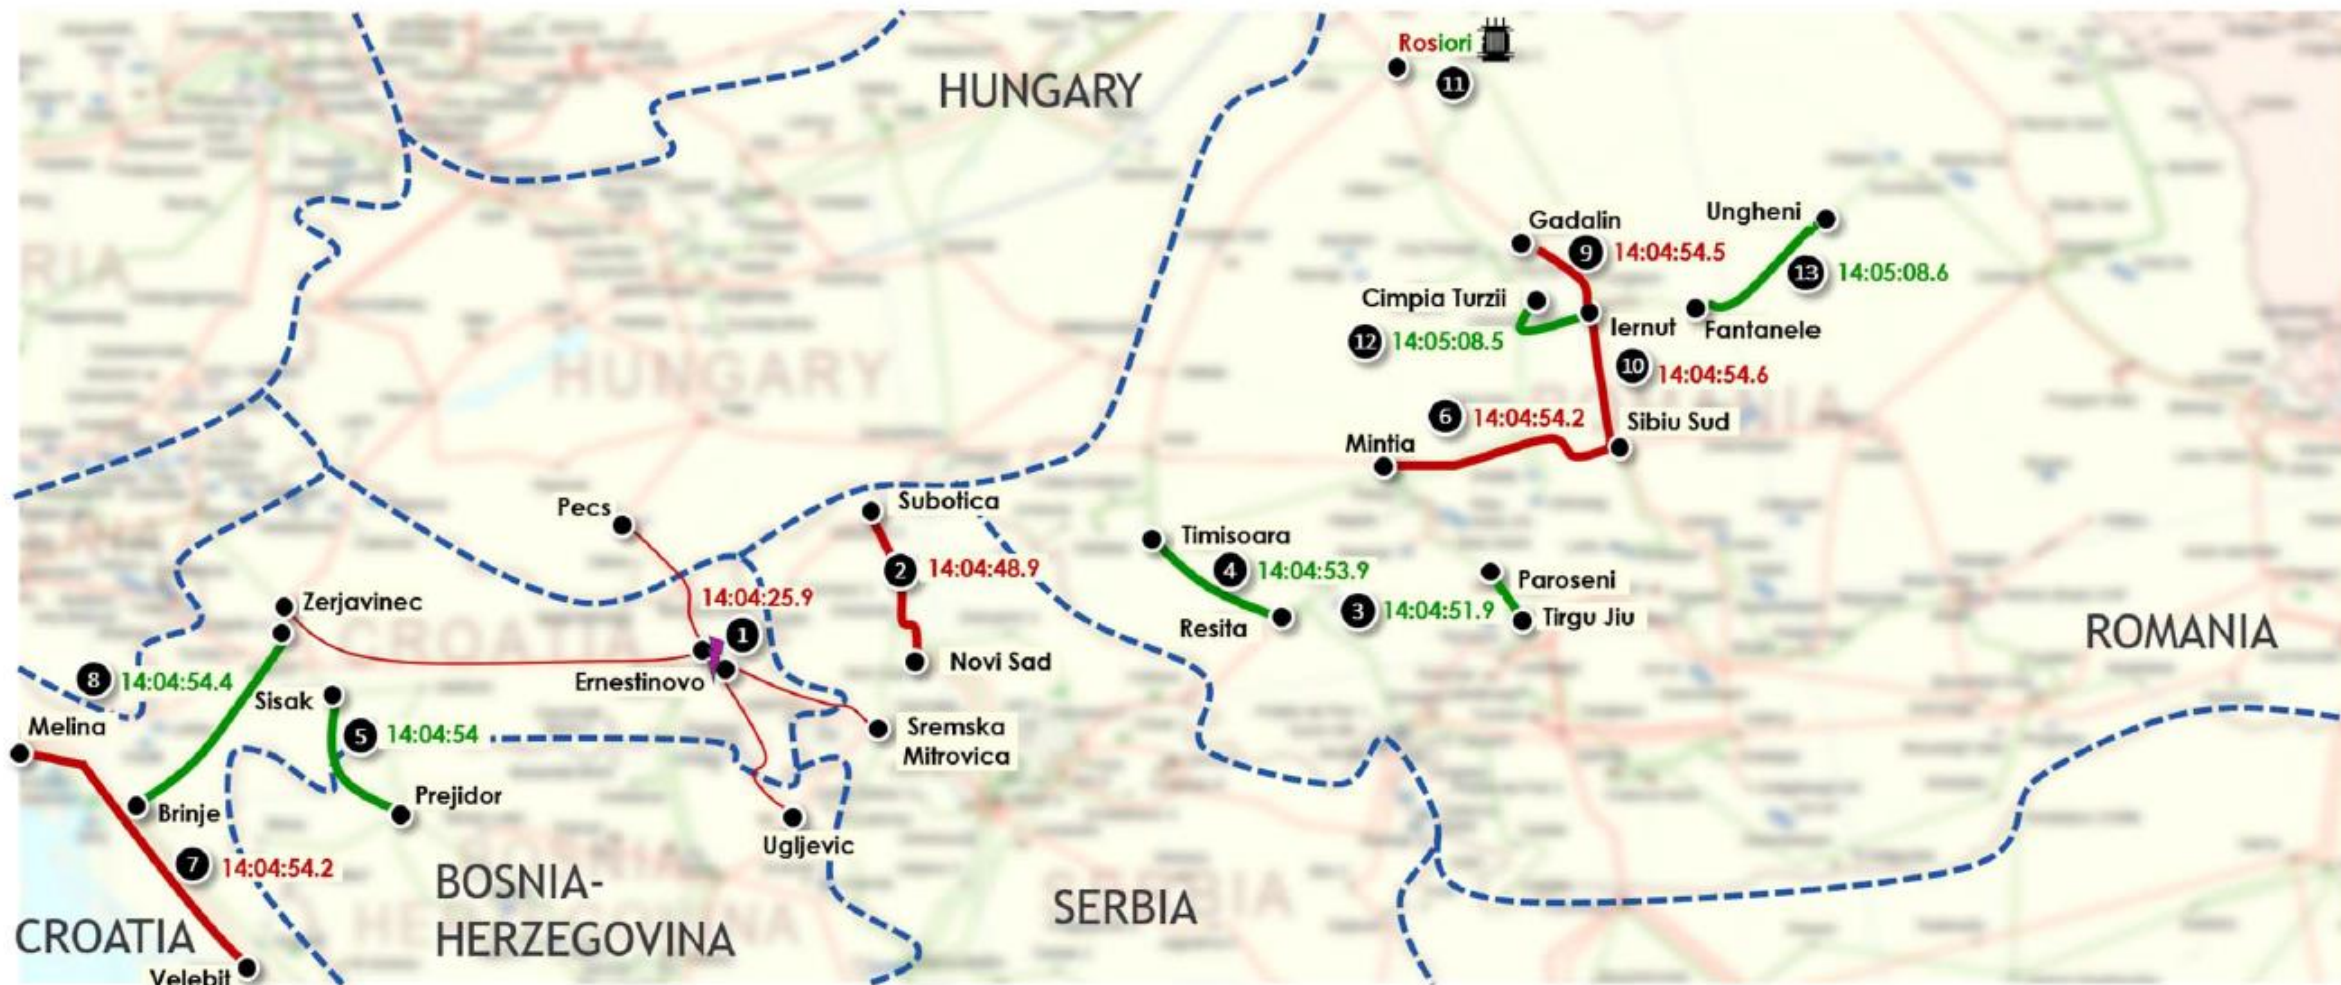
Kaskáda vypnutí:

Nr.	TSO	delta / s	trip time	substation 1	substation 2	voltage / kV	Comments	
1	HOPS	0	14:04:25.9	Ernestinovo		400	busbar coupler overload protection	23 s
2	EMS	23	14:04:48.9	Subotica	Novi Sad	400	overload protection 20 s 2nd zone	
3	TRANS	26	14:04:51.9	Paroşeni	Târgu Jiu	220	distance prot. starting zone 2.4 s	19.7 s
4a	TRANS	27.9	14:04:53.8	Reşiţa	Timişoara	220	dist. prot. 0.4 s	
4b	TRANS	27.9	14:04:53.8	Reşiţa	Timişoara	220	dist. prot. 0.4 s, breaker L1 failure	
5	NOS BIH	28.2	14:04:54.1	Prijedor	Međurič	220	dist. prot. out-of-step protection	
6	NOS BIH	28.2	14:04:54.1	Prejedor	Sisak	220	dist. prot. out-of-step protection	
7	HOPS	28.3	14:04:54.2	Melina	Velebit	400	dist. prot. zone 3	
8	TRANS	28.3	14:04:54.2	Mintia	Sibiu	400	distance prot. power swing cond.	
9	HOPS	28.5	14:04:54.4	Brinje	Padene	220	dist. prot. zone 1	
10	TRANS	28.6	14:04:54.5	Gădălin	Iernut	400	distance prot. power swing cond. zone 2 0.4 s

11	TRANS	28.7	14:04:54.6	Sibiu Sud	Iernut	400	dist. prot. zone 3 reverse 0.6 s	
12	TRANS	28.7	14:04:54.6	Transf 400/220	Roşiori	400/220	dist. prot. power swing cond.	
13	TRANS	42.6	14:05:08.5	Iernut	Câmpia Turzii	220	dist. prot. zone 2 power swing conditions	
14	TRANS	42.7	14:05:08.6	Fântânele	Ungheni	220	dist. prot. zone 2 power swing conditions

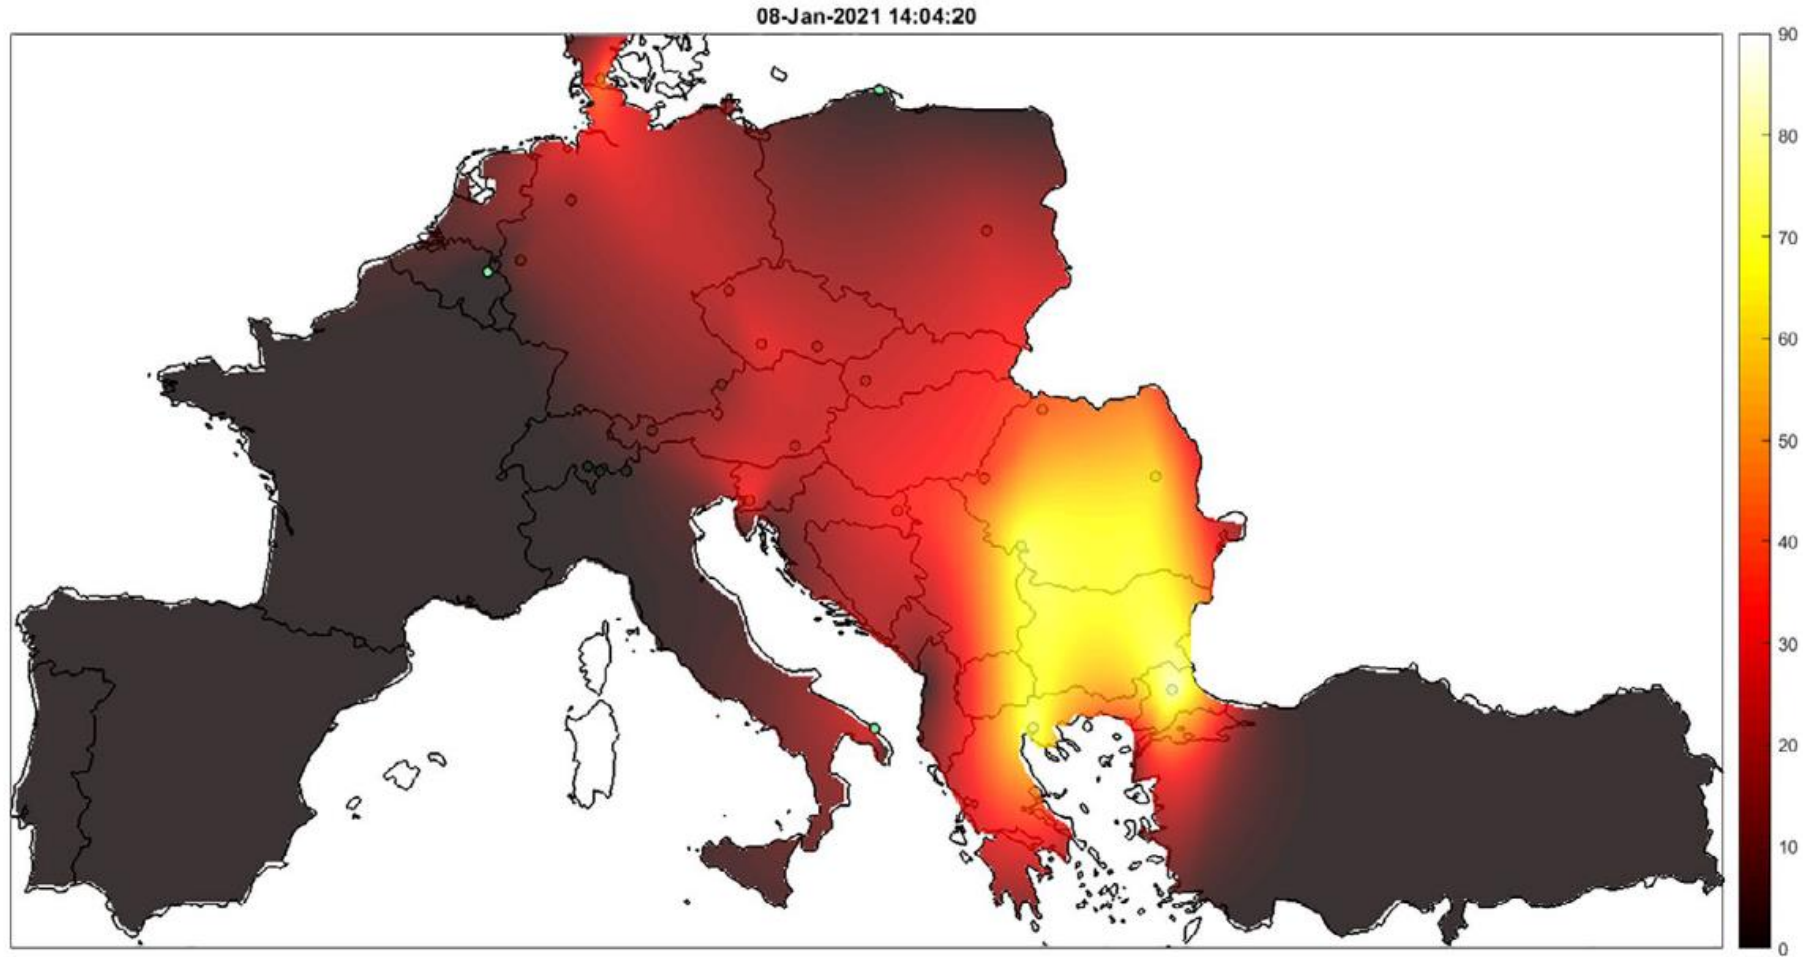
Figure 1.6: Voltage phase angle heat map representation

- Uhly: Z dôvodu vysokých tokov z východnej časti CE do západnej časti CE je zrejmé, že z dôvodu rozdielov uhlov medzi oblasťami bola prevádzka blízko uhlovej nestability už pred vypnutím SP 400 kV Ernestinovo
- Frekvencia: vidno, že už po výpadku SP 400 kV Ernestinovo došlo k viditeľnému vplyvu na stabilitu. Oscilácie boli utlmené pred výpadkom Subotica – Novi Sad
- Po výpadku vedenia Subotica – Novi Sad už nebolo návratu do stabilnej prevádzky a došlo k rozpadu CE

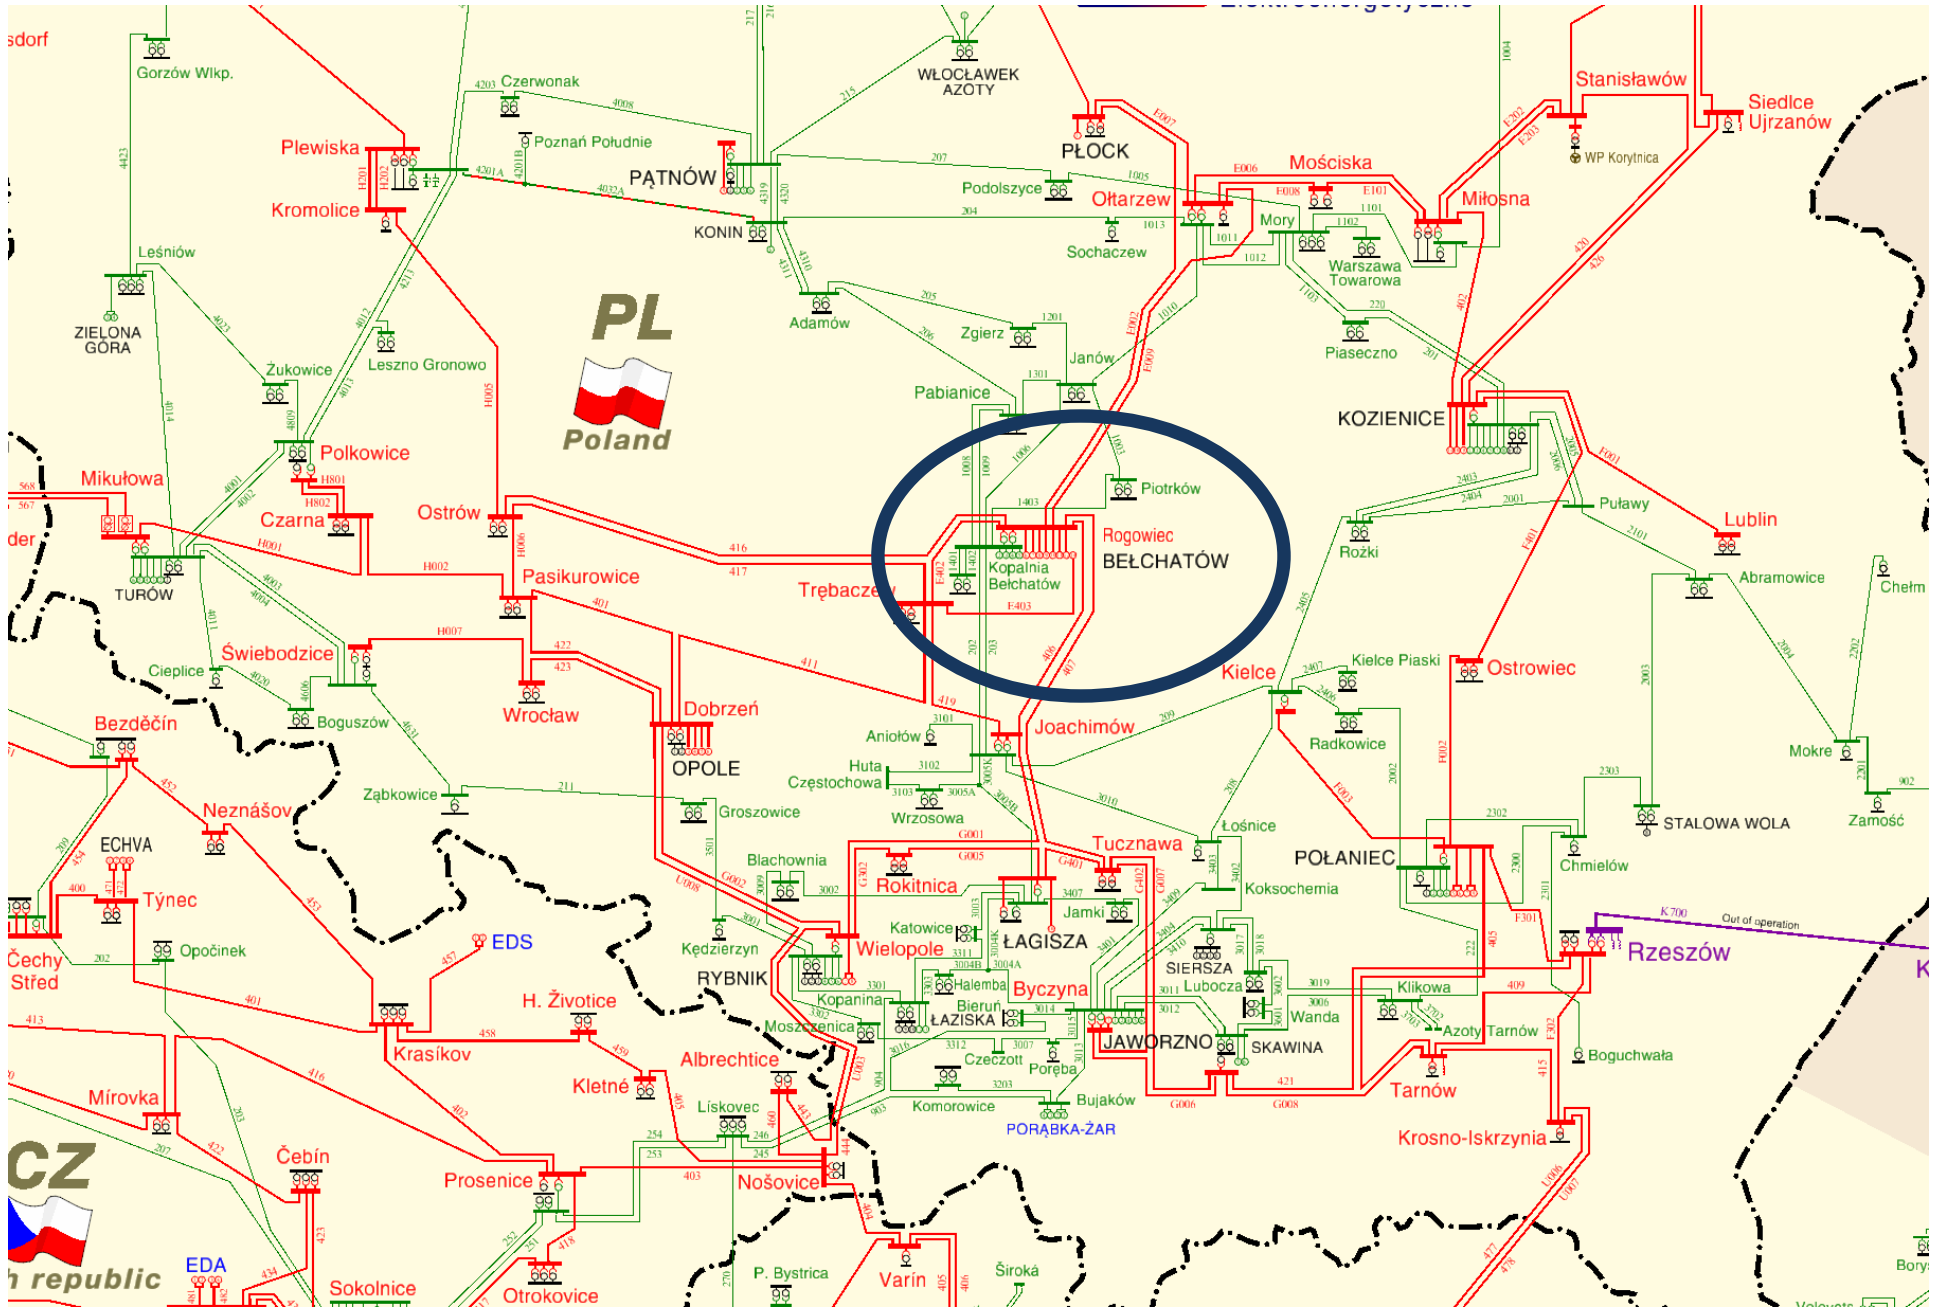
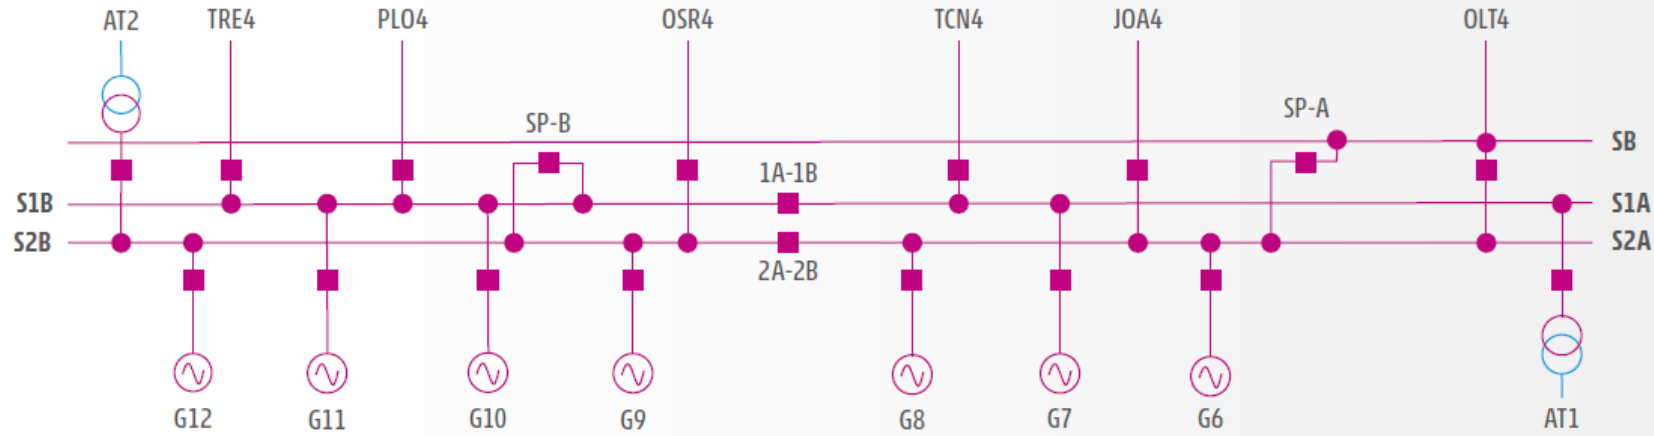
Figure 2: Line diagram of R-400 kV substation Rogowiec.

16:34:09	R-400 kV ROG, line OLT4	Closure of phase L2 of the line earthing switch, caused by human error.
16:34:09	R-400 kV ROG, line OLT4	Tripping phase L2 circuit breaker by the protection devices, responding to a 1-phase short-circuit, which was followed by activation of auto-reclose.

- Ľudský činiteľ – chybná manipulácia na vedení 400 kV Rogowiec – Oltarzew, po vypnutí vypínača aktivácia opätovného zapínania, ktorá poškodila uzemňovaciu sieť aj súvisiace zariadenia, konštrukcia uzemňovacej siete odlišná od projektov
- Vypnutie pripojených zdrojov bolo spôsobené chybným pôsobením, vypnutie vypínačov mnohonásobnými impulzami (riadiacimi signálmi) z dôvodu výskytu prepätí, ktoré vznikli skratovým prúdom, ktorý nebol dostatočne absorbovaný z dôvodu zlej uzemňovacej sústavy

- Rozdelenie prevádzky Est Rogowiec
- Renovácia uzemňovacej siete

- Rekonštrukcia elektrickej stanice

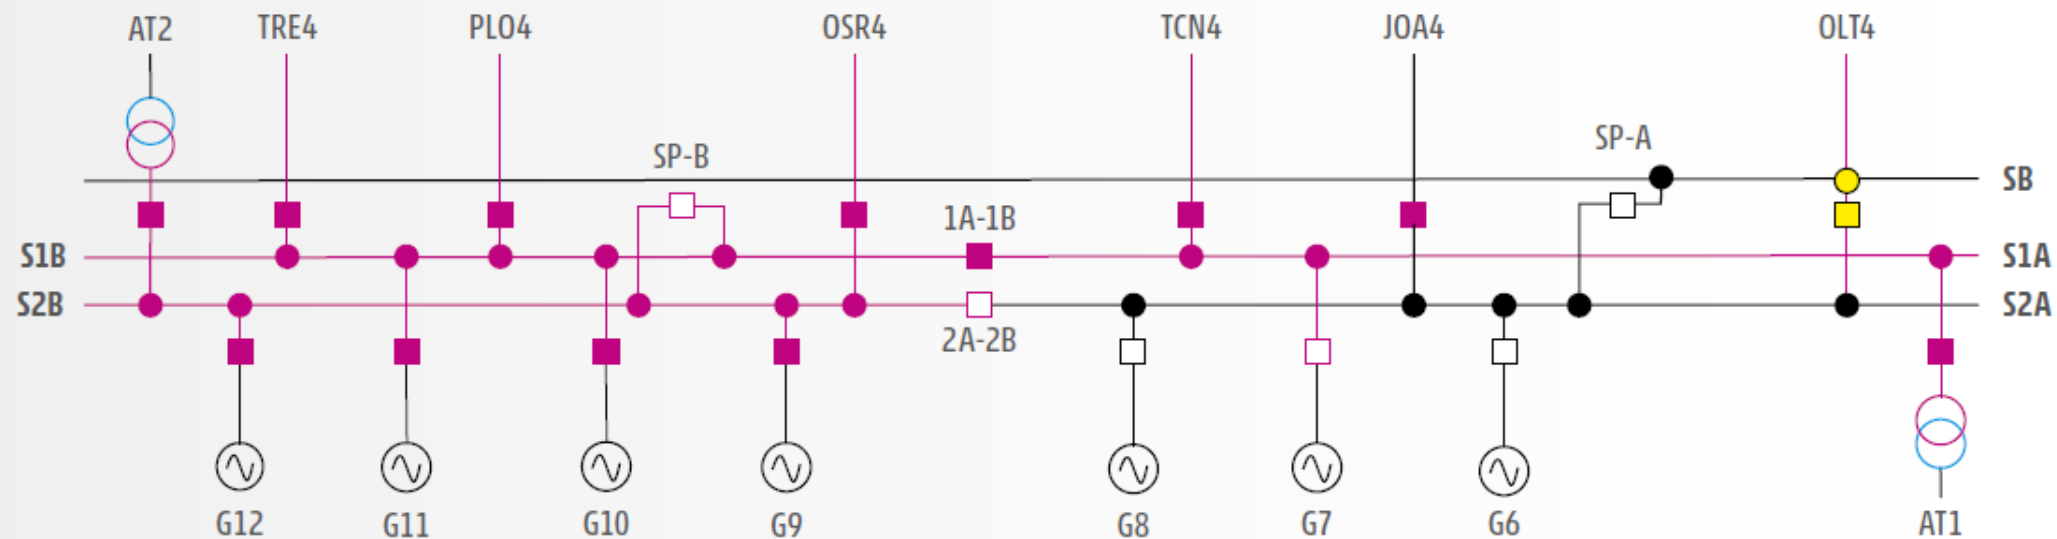
Figure 5: Line diagram of R-400 kV substation Rogowiec after the incident (black - no voltage).

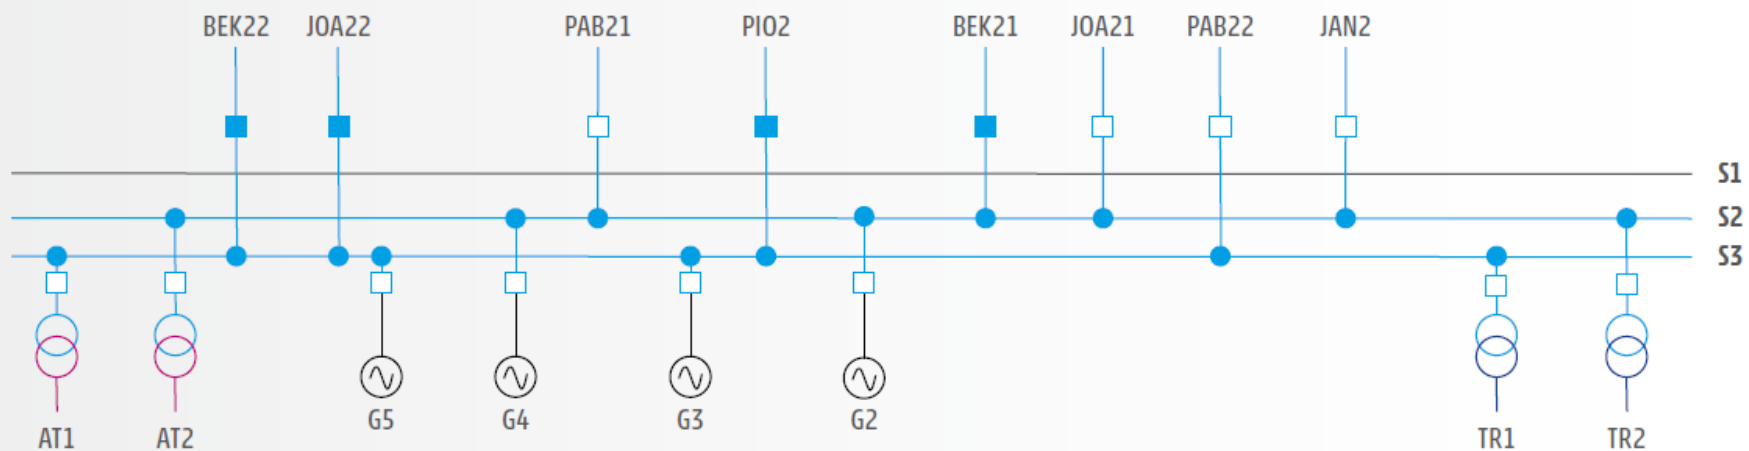
Figure 6: Line diagram of R-220 kV substation Rogowiec after the incident (black - no voltage).

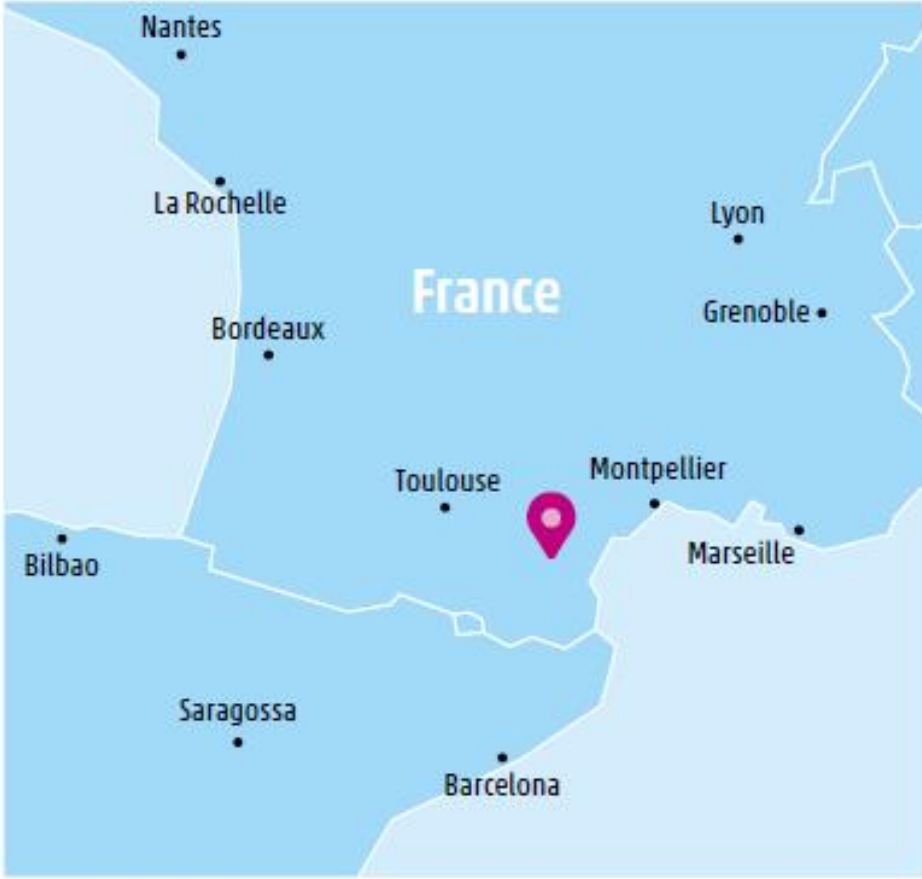
- Dňa 24. júla 2021 o 16:36h. došlo k oddeleniu sústav Španielska, Portugalska a časti francúzskej sústavy od siete kontinentálnej Európy
- Dôvodom bol incident vo Francúzsku – požiar v oblasti 400 kV vedení Baixas - Gaudiere

Figure 1: Location of the fire on a large-scale map.

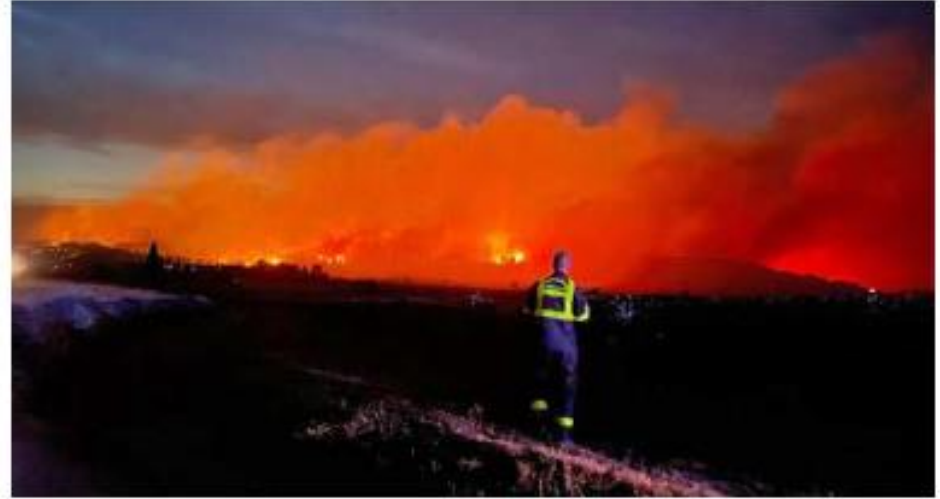
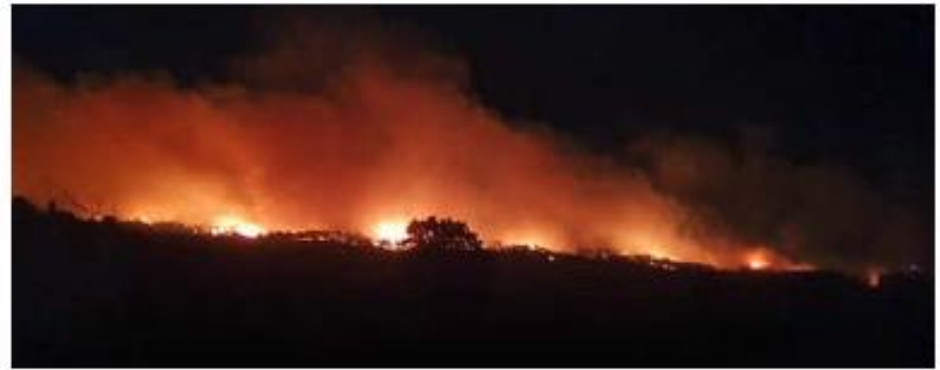
Figure 2 & 3: Picture taken during firefighting activities.

- Príčinou výpadku bol lesný požiar v blízkosti vedení, ktorý spôsobil tepelnú vlnu a vysokú teplotu v oblasti. Následne došlo k značnému znečisteniu prostredia následkom čoho došlo k zníženiu izolačných vlastností a degradácii elektrických vlastností vzduchu - čo viedlo ku skratu a vypnutiu vedení
