Významné výpadky v kontinentálnej Európe v roku 2021

Ing. Stanislav Prieložný

SEPS, a.s.

Poráč 3.11.2022

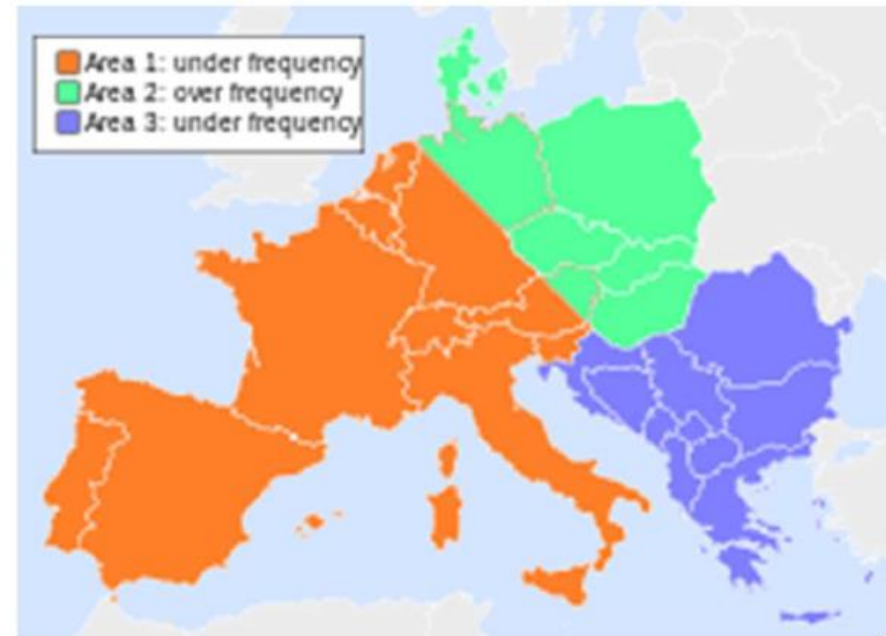
- Dňa 8. januára 2021 o 14:05 sa synchrónne prepojená sústava kontinentálnej Európy (CE) rozdelila na dve separátne časti z dôvodu výpadku niekoľkých sieťových prvkov (Chorvátsko, Srbsko, Rumunsko)
- Ide o najväčší výpadok v CE od poruchy v

Novembri 2006, kedy sa CE rozdelila na tri ostrovy

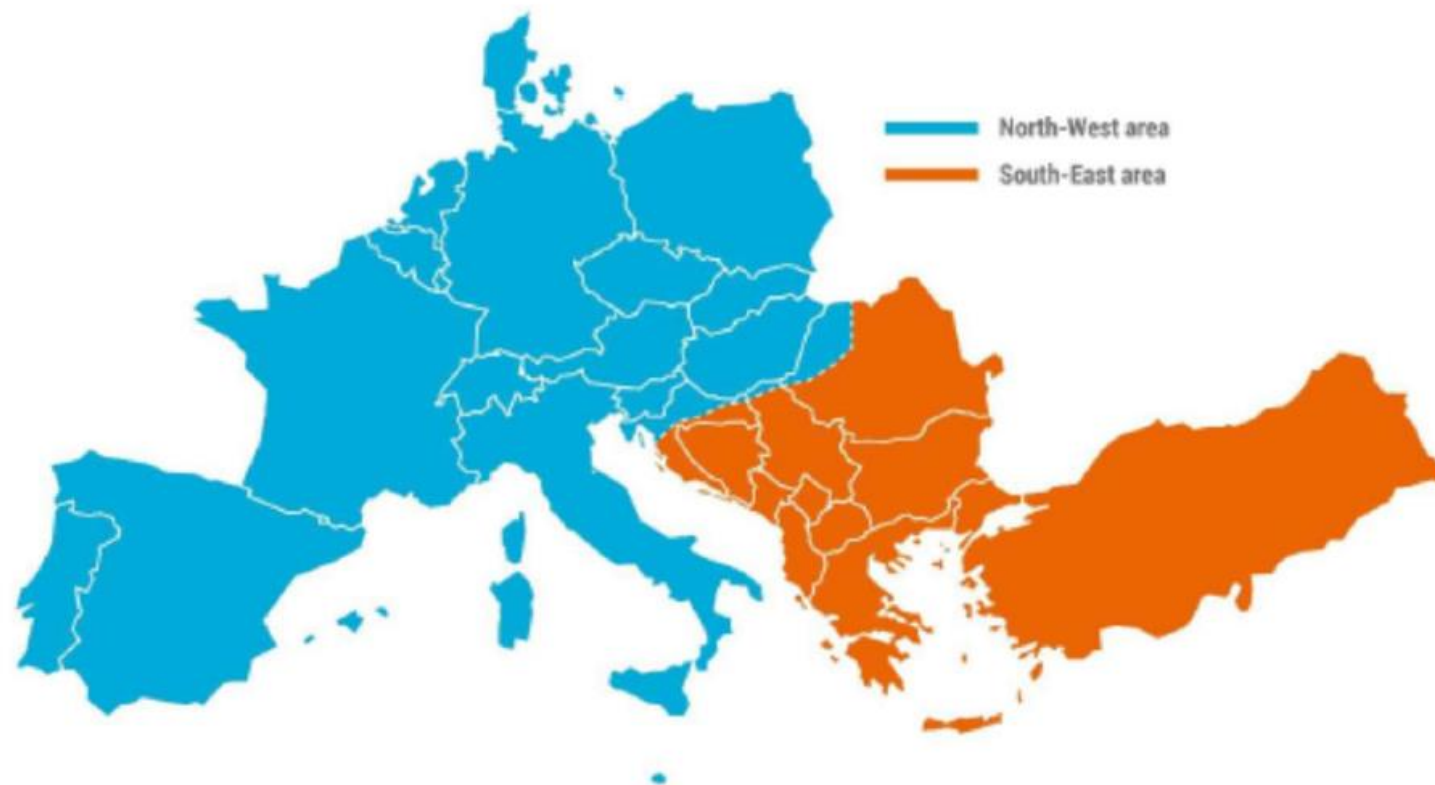
Rozdelenie prevádzky na dve časti
spôsobilo, že:

- North-West area bola s deficitom - 5.7 GW
- South-East area bola s prebytkom okolo + 5.7 GW

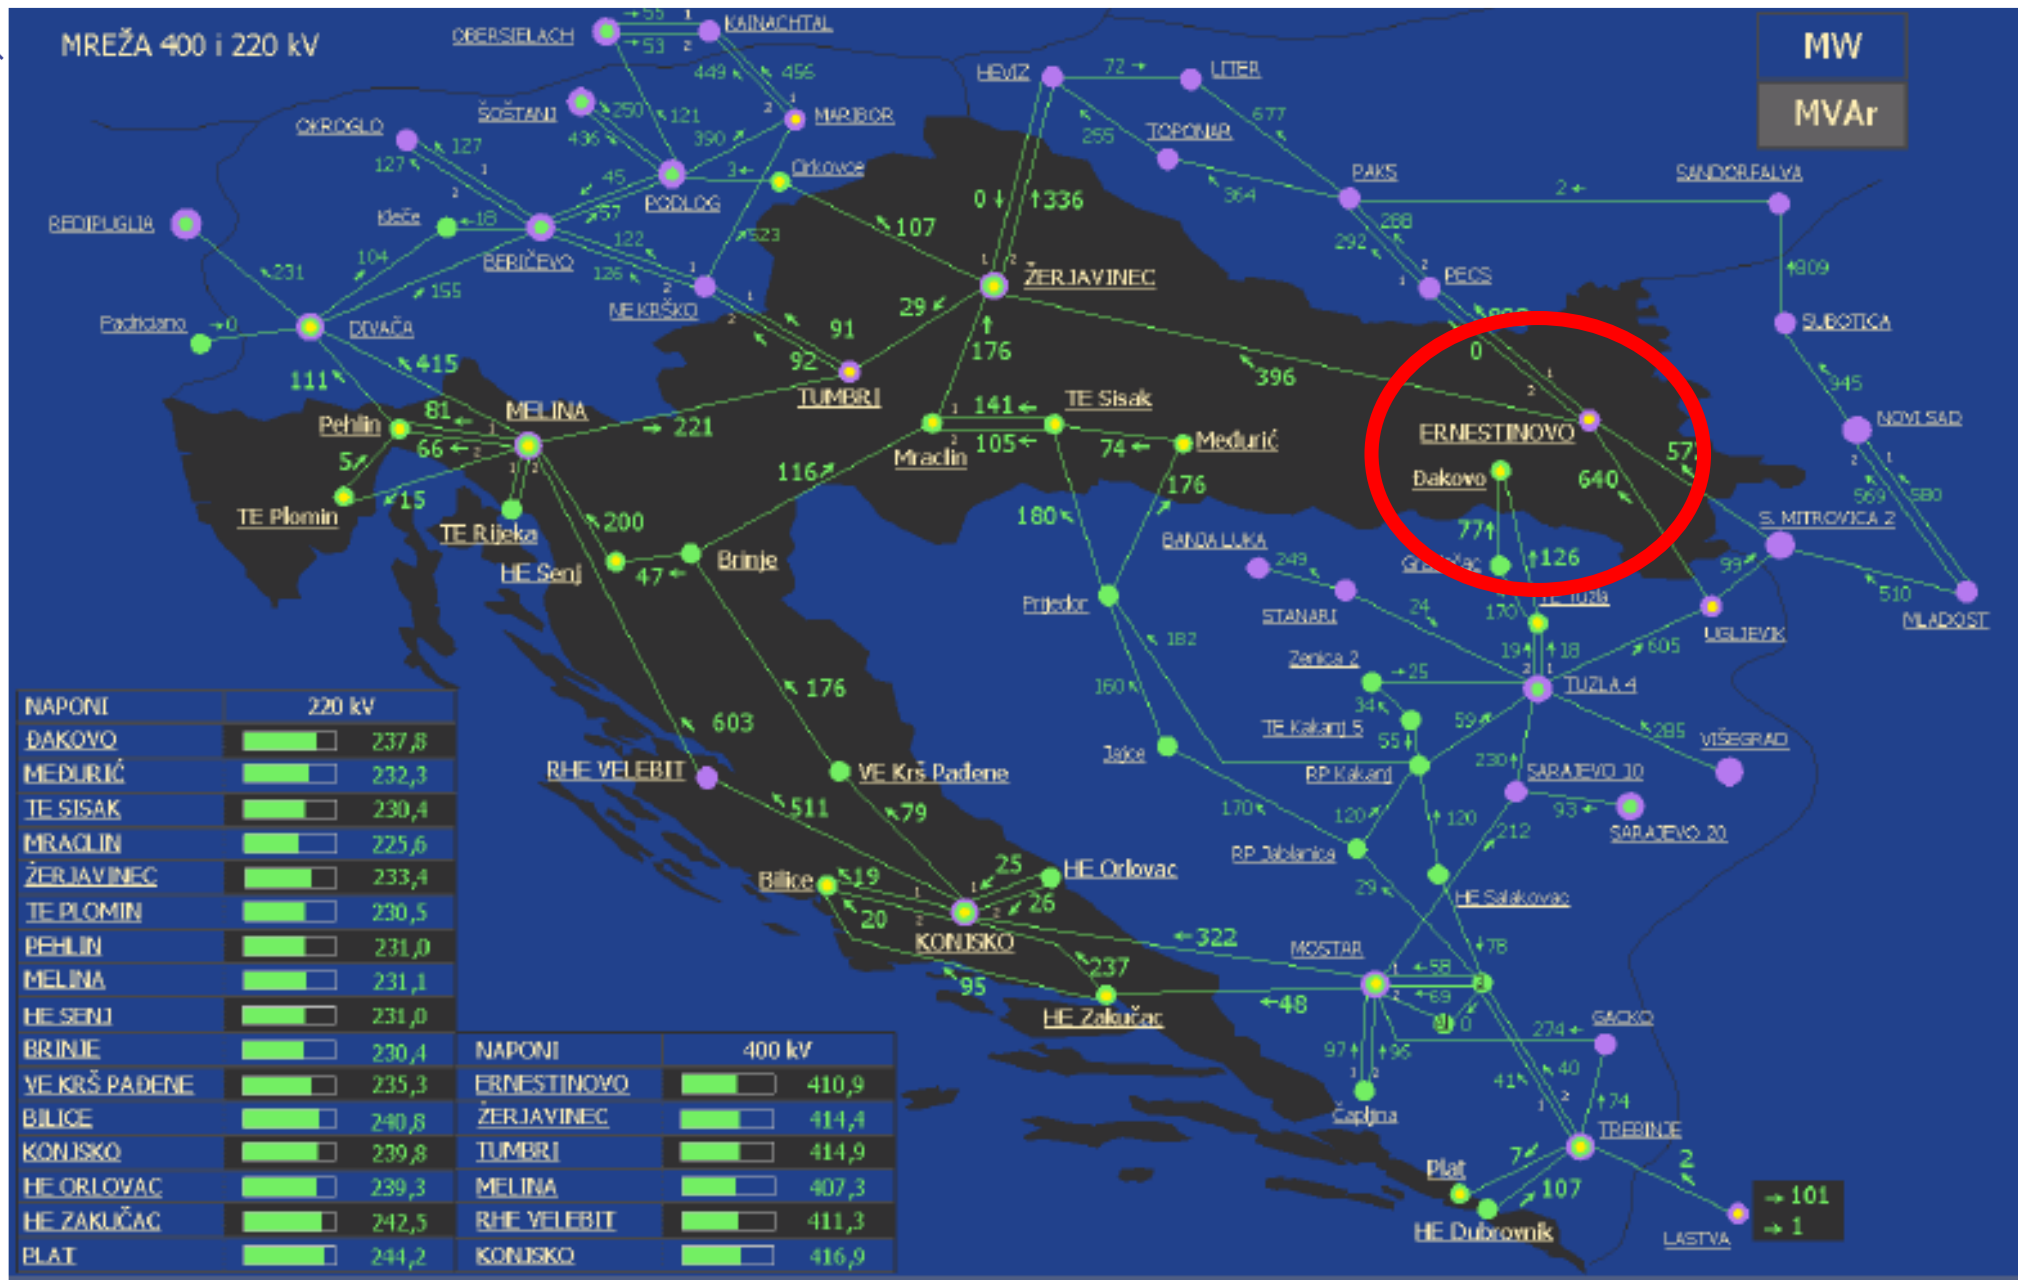
Rozvodňa 400 kV Ernestinovo

- 14:04:25 – inicializačná udalosť: vypnutie spínača prípojnic 400 kV Ernestinovo – **vypnutie nadprúdovými ochranami, pred vypnutím boli na prelome hodín detekované zvýšené toky v Rz Ernestinovo**
- Vypnutie spínača prípojnic 400 kV Ernestinovo spôsobilo presun zaťaženia na 400 kV vedenie Subotica – Novi Sad, čo spôsobilo vypnutie tohto vedenia taktiež nadprúdovými ochranami
- **Vyššie uvedené vypnutia spôsobili, že systém sa dostal do nestability, čo spôsobilo ďalšiu kaskádu vypnutí od Rumunska až po Dalmáciu**

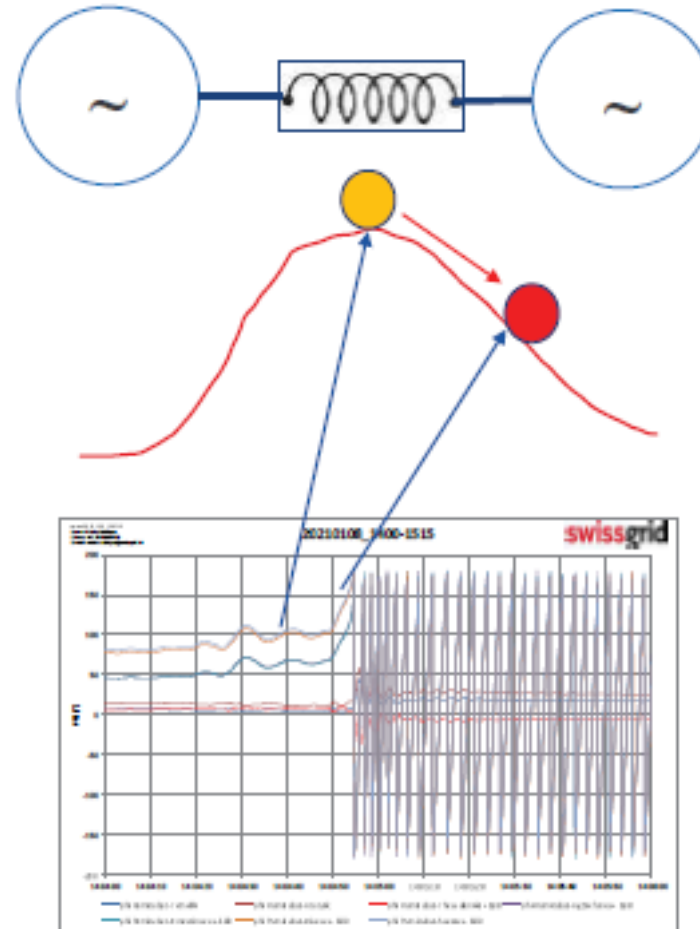
Druhá udalosť: vypnutie vedenia 400 kV Novi Sad - Subotica

Situácia v sústave sa dostala do nezvratného stavu a nestability a nasledovala kaskáda ďalších vypnutí

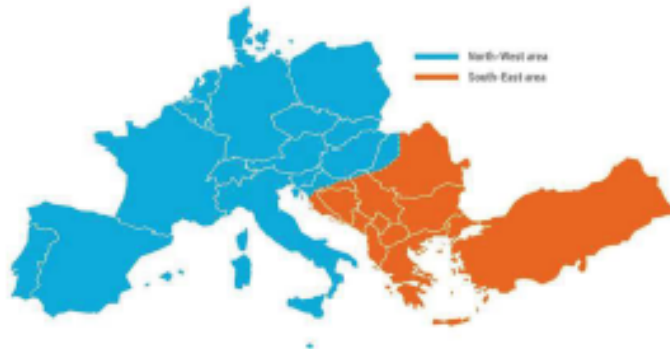
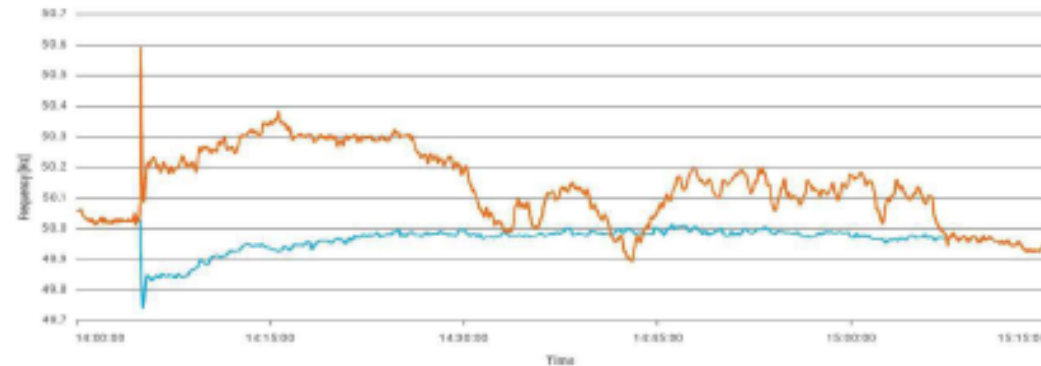
Ďalšia kaskáda vypnutí od Rumunska až po Dalmáciu

Nr.	TSO	delta / s	trip time	substation 1	substation 2	voltage / kV	Comments	
1	HOPS	0	14:04:25.9	Ernestinovo		400	busbar coupler overload protection	23 s
2	EMS	23	14:04:48.9	Subotica	Novi Sad	400	overload protection 20 s 2nd zone	
3	TRANS	26	14:04:51.9	Paroşeni	Târgu Jiu	220	distance prot. starting zone 2.4 s	19.7 s
4a	TRANS	27.9	14:04:53.8	Reşiţa	Timişoara	220	dist. prot. 0.4 s	
4b	TRANS	27.9	14:04:53.8	Reşiţa	Timişoara	220	dist. prot. 0.4 s, breaker L1 failure	
5	NOS BIH	28.2	14:04:54.1	Prijedor	Međurič	220	dist. prot. out-of-step protection	
6	NOS BIH	28.2	14:04:54.1	Prejedor	Sisak	220	dist. prot. out-of-step protection	
7	HOPS	28.3	14:04:54.2	Melina	Velebit	400	dist. prot. zone 3	
8	TRANS	28.3	14:04:54.2	Mintia	Sibiu	400	distance prot. power swing cond.	
9	HOPS	28.5	14:04:54.4	Brinje	Padene	220	dist. prot. zone 1	
10	TRANS	28.6	14:04:54.5	Gădălin	Iernut	400	distance prot. power swing cond. zone 2 0.4 s

11	TRANS	28.7	14:04:54.6	Sibiu Sud	Iernut	400	dist. prot. zone 3 reverse 0.6 s	
12	TRANS	28.7	14:04:54.6	Transf 400/220	Roşiori	400/220	dist. prot. power swing cond.	
13	TRANS	42.6	14:05:08.5	Iernut	Câmpia Turzii	220	dist. prot. zone 2 power swing conditions	
14	TRANS	42.7	14:05:08.6	Fântânele	Ungheni	220	dist. prot. zone 2 power swing conditions

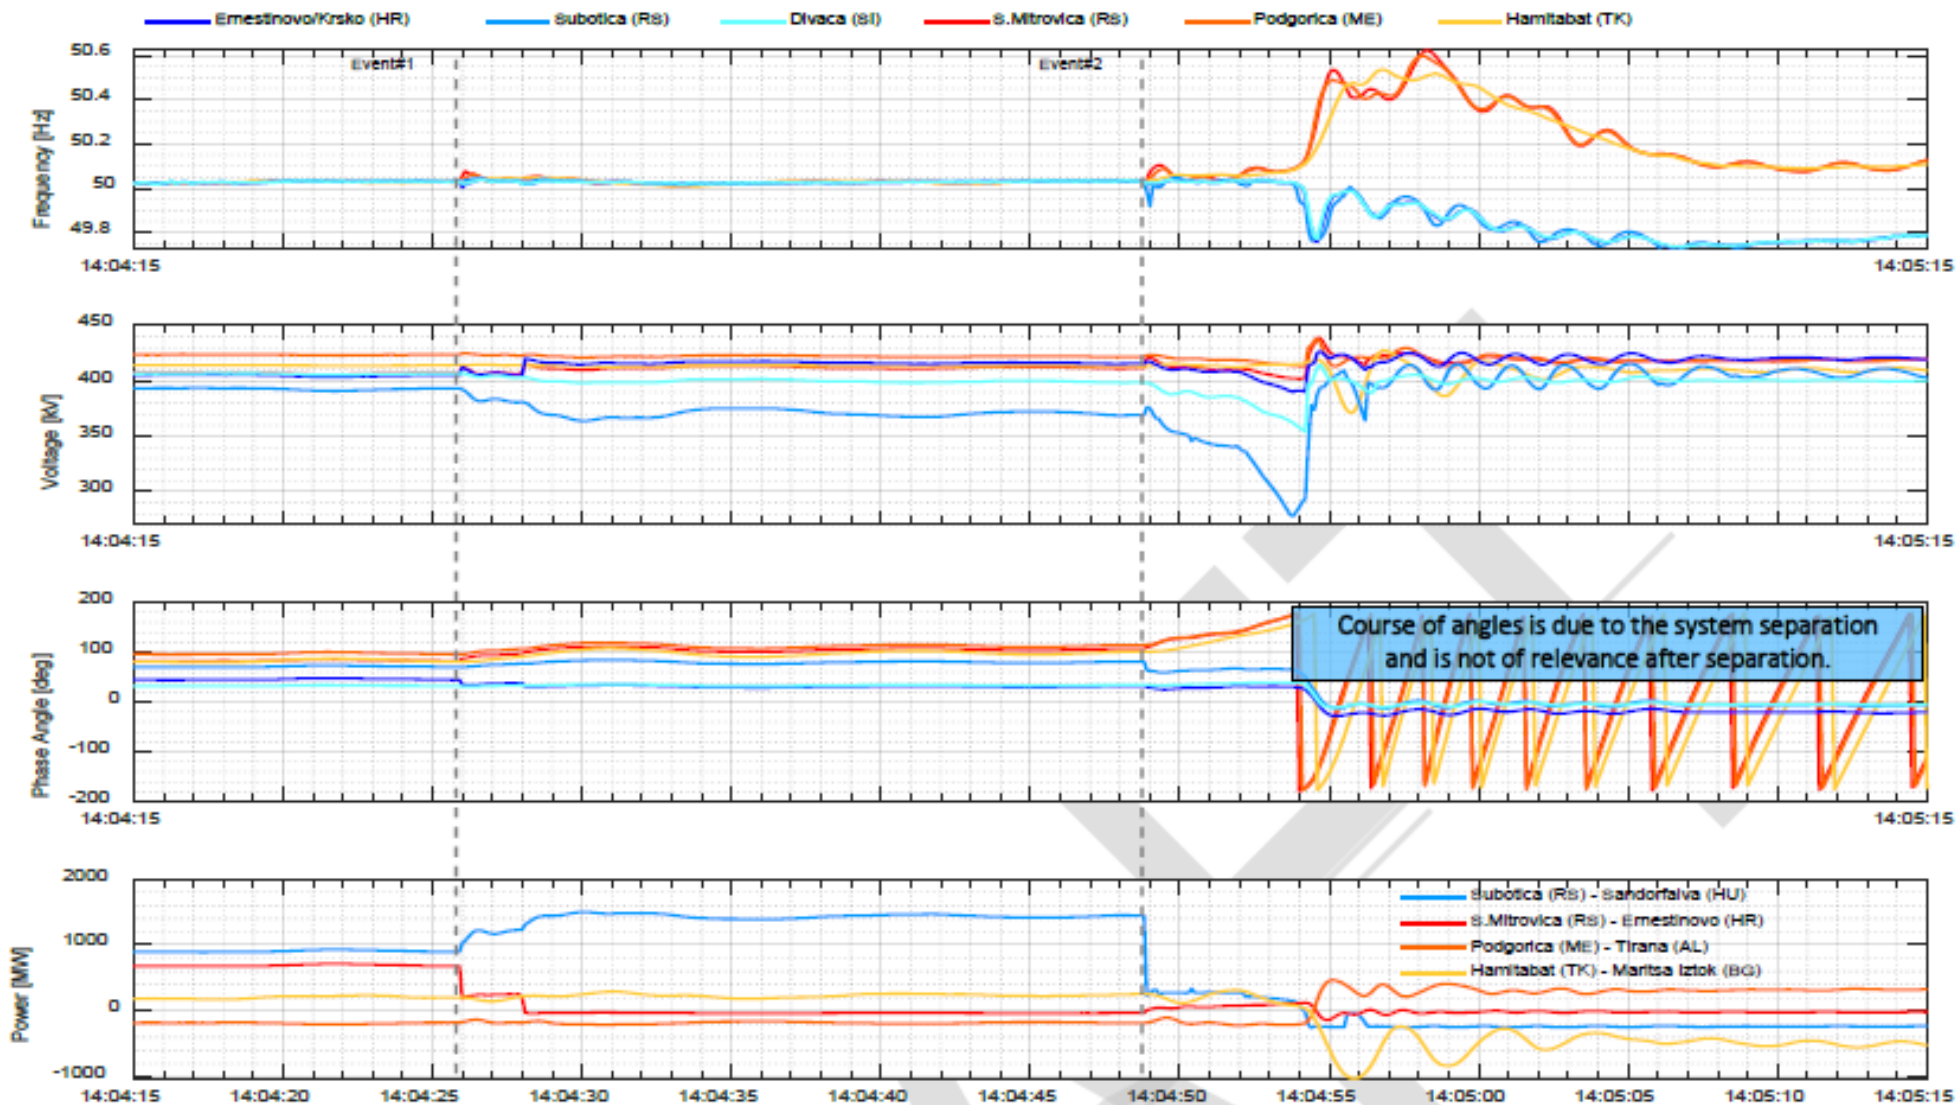
Priebehy frekvencie, napätie, uhlov a činných výkonov počas výpadku

- Uhly: Z dôvodu vysokých tokov z východnej časti CE do západnej časti CE je zrejmé, že z dôvodu rozdielov uhlov medzi oblasťami bola prevádzka blízko uhlovej nestability už pred vypnutím SP 400 kV Ernestinovo
- Frekvencia: vidno, že už po výpadku SP 400 kV Ernestinovo došlo k viditeľnému vplyvu na stabilitu. Oscilácie boli utlmené pred výpadkom Subotica – Novi Sad
- Po výpadku vedenia Subotica – Novi Sad už nebolo návratu do stabilnej prevádzky a došlo k rozpadu CE

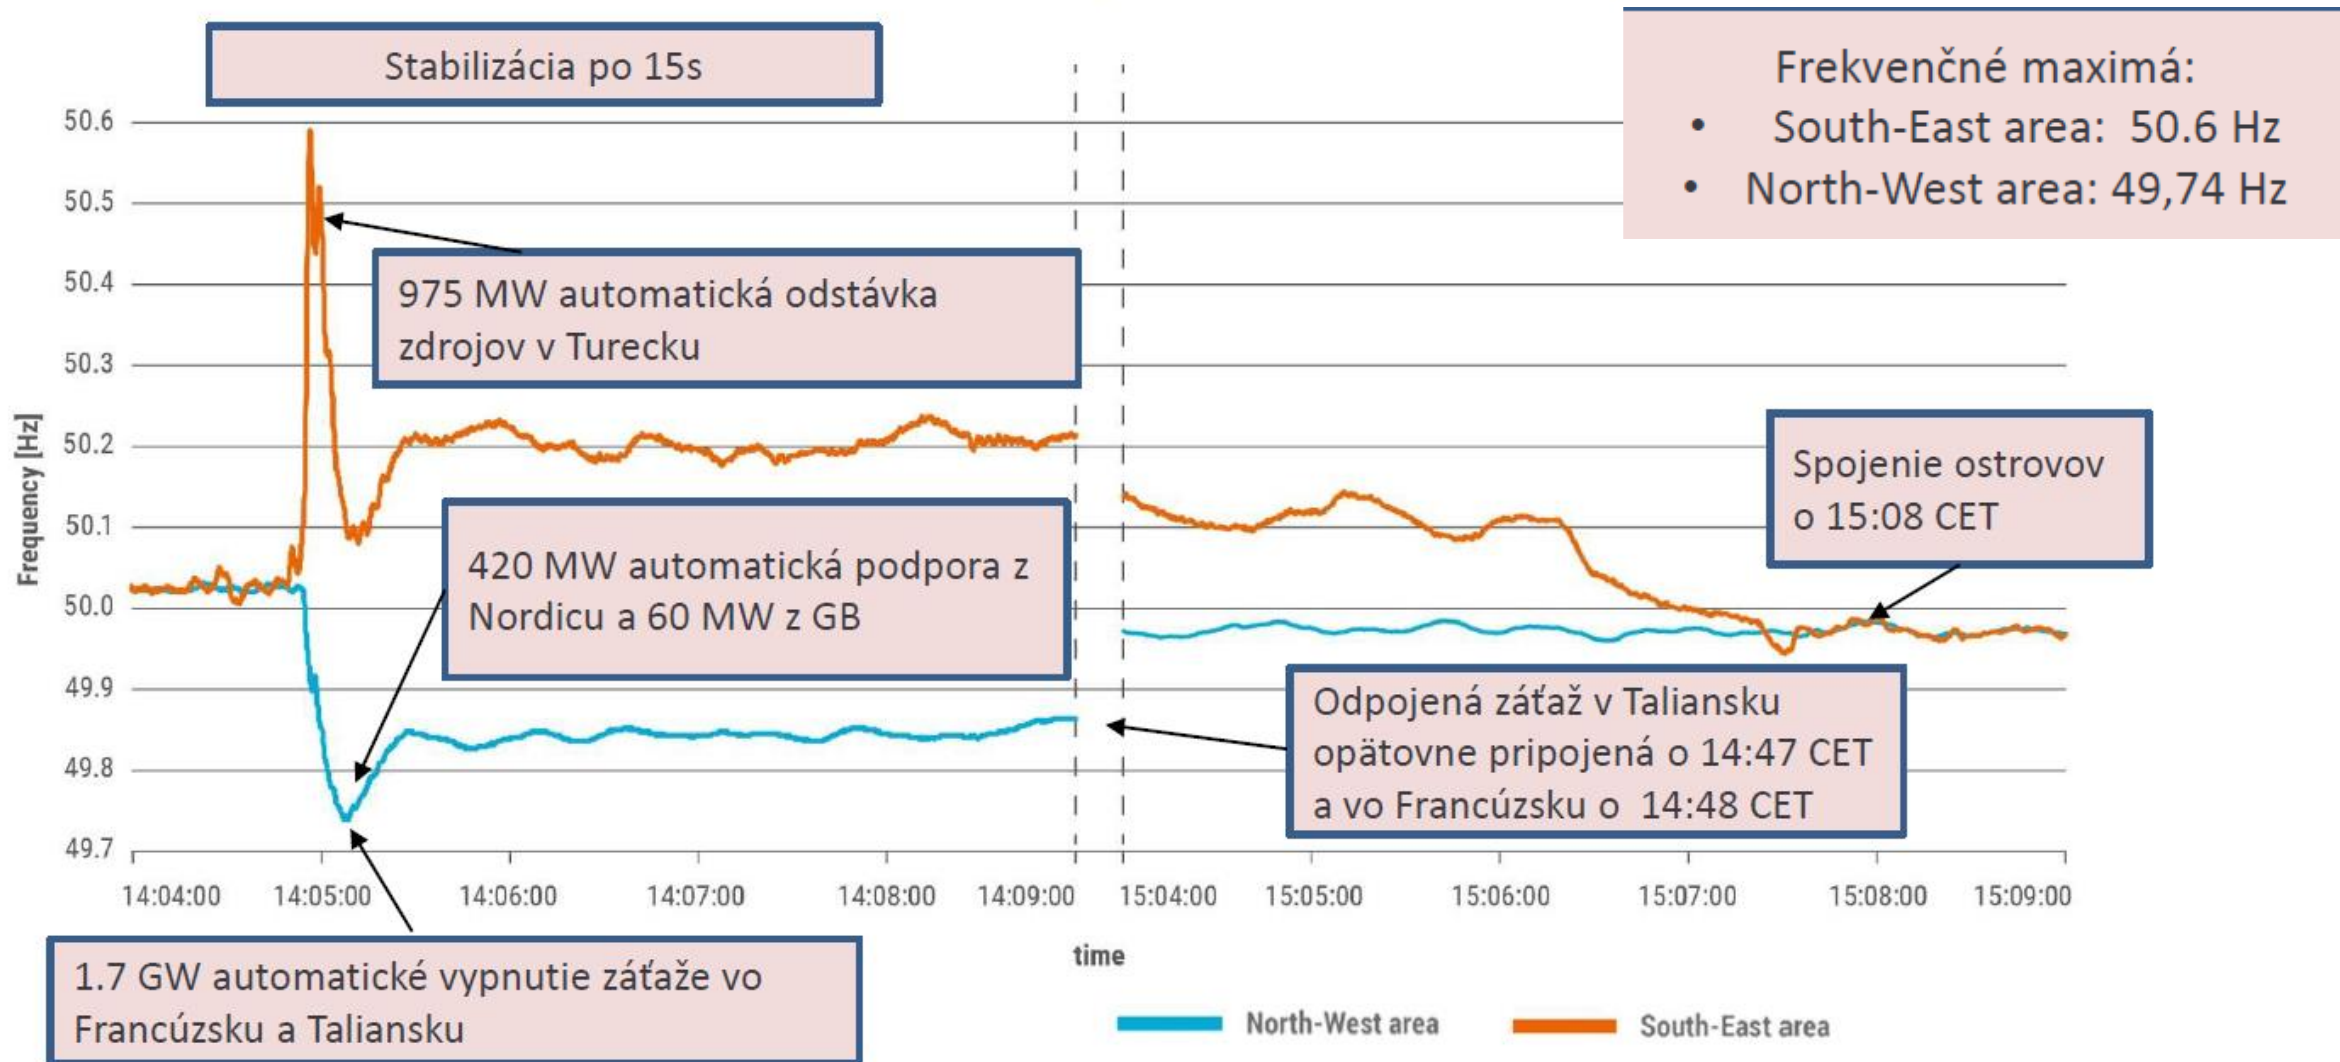
Priebeh frekvencie v rozdelených oblastiach CE po výpadku

- Tieto a ďalšie (v rámci ďalších krajín vrátane SR) opatrenia v severozápadnej časti CE zabezpečili, že sa už v čase 14:09h. sa dostala frekvencia v tejto časti na úroveň - 100 mHz od 50 Hz.
- V juhovýchodnej časti CE z dôvodu vysokej frekvencie došlo k redukcii výroby a frekvencia v tejto časti sústavy dosiahla odchýlku + 100 mHz od 50 Hz v čase 15:05 h.

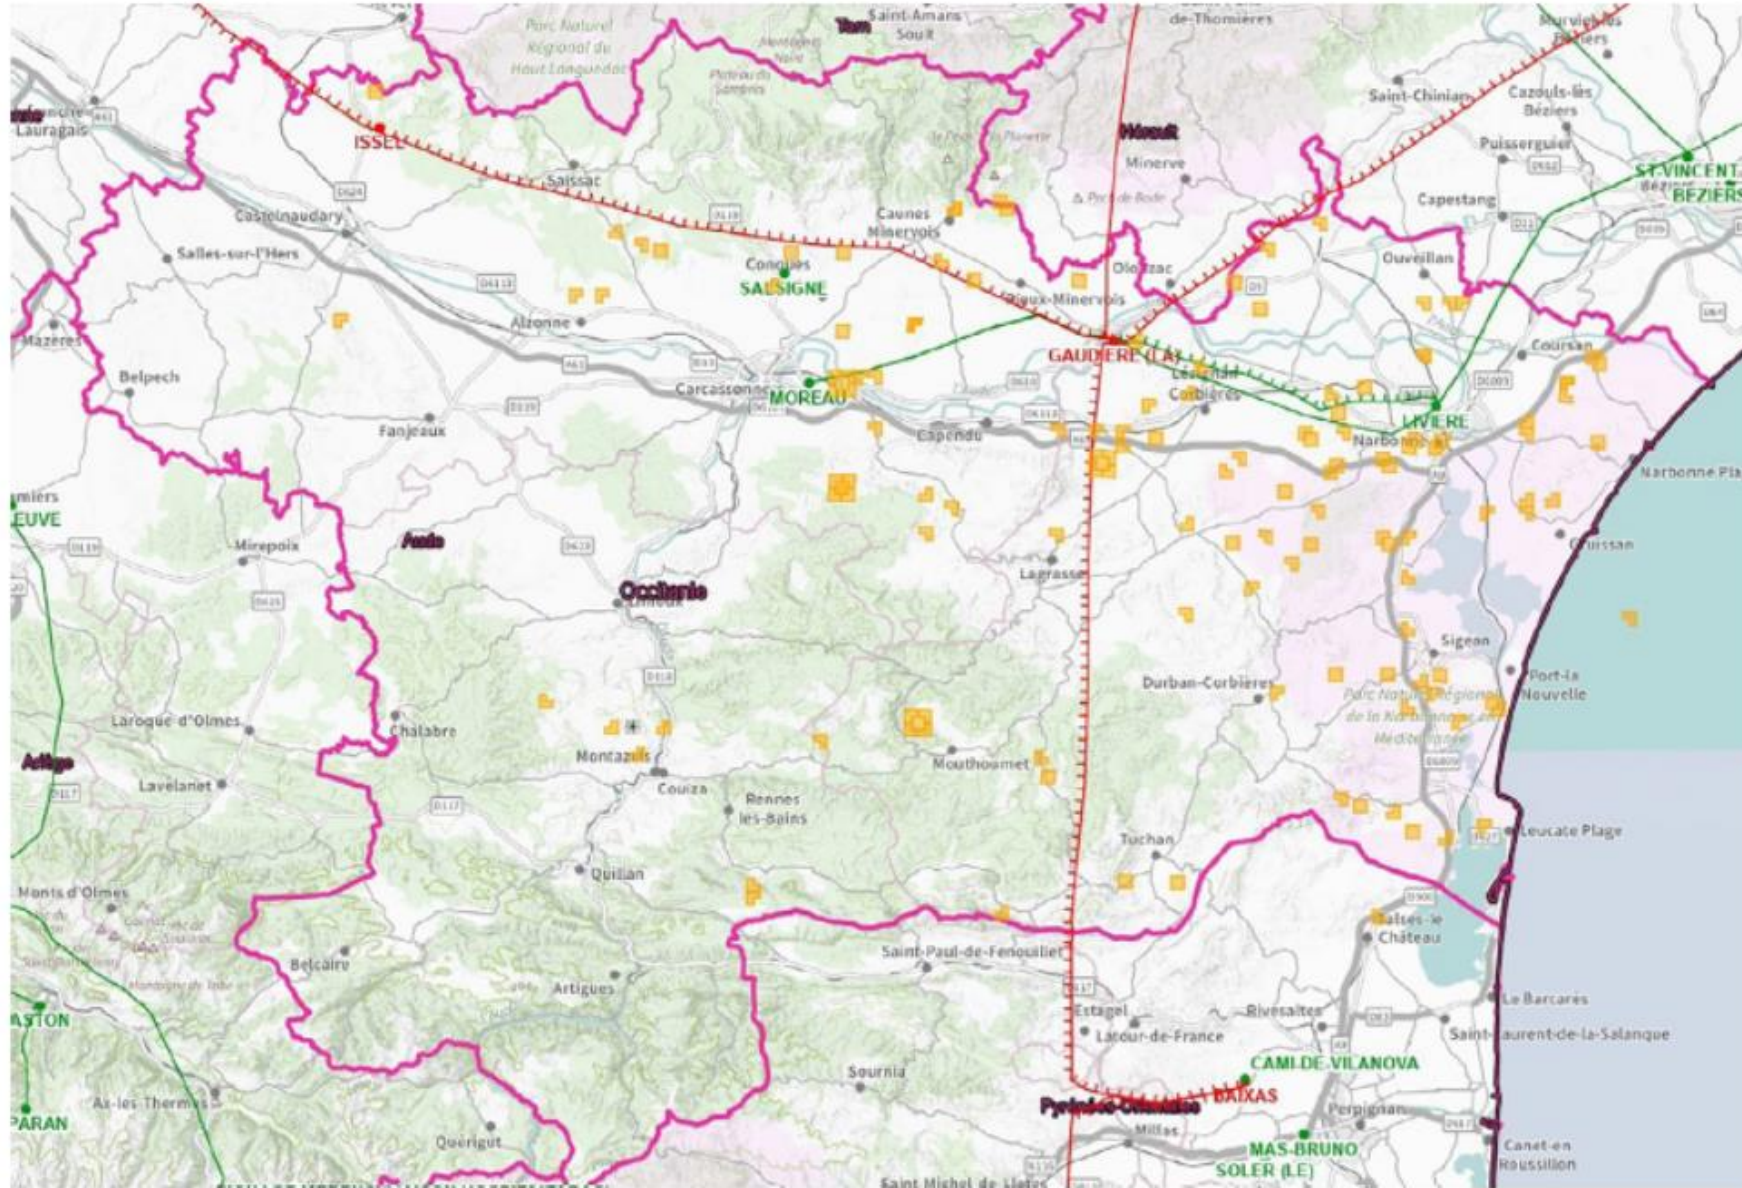
Početnosť požiarov za posledných 20 rokov v danej oblasti

- Príčinou výpadku bol lesný požiar v blízkosti vedení, ktorý spôsobil tepelnú vlnu a vysokú teplotu v oblasti. Následne došlo k značnému znečisteniu prostredia následkom čoho došlo k zníženiu izolačných vlastností a degradácii elektrických vlastností vzduchu - čo viedlo ku skratu a vypnutiu vedení

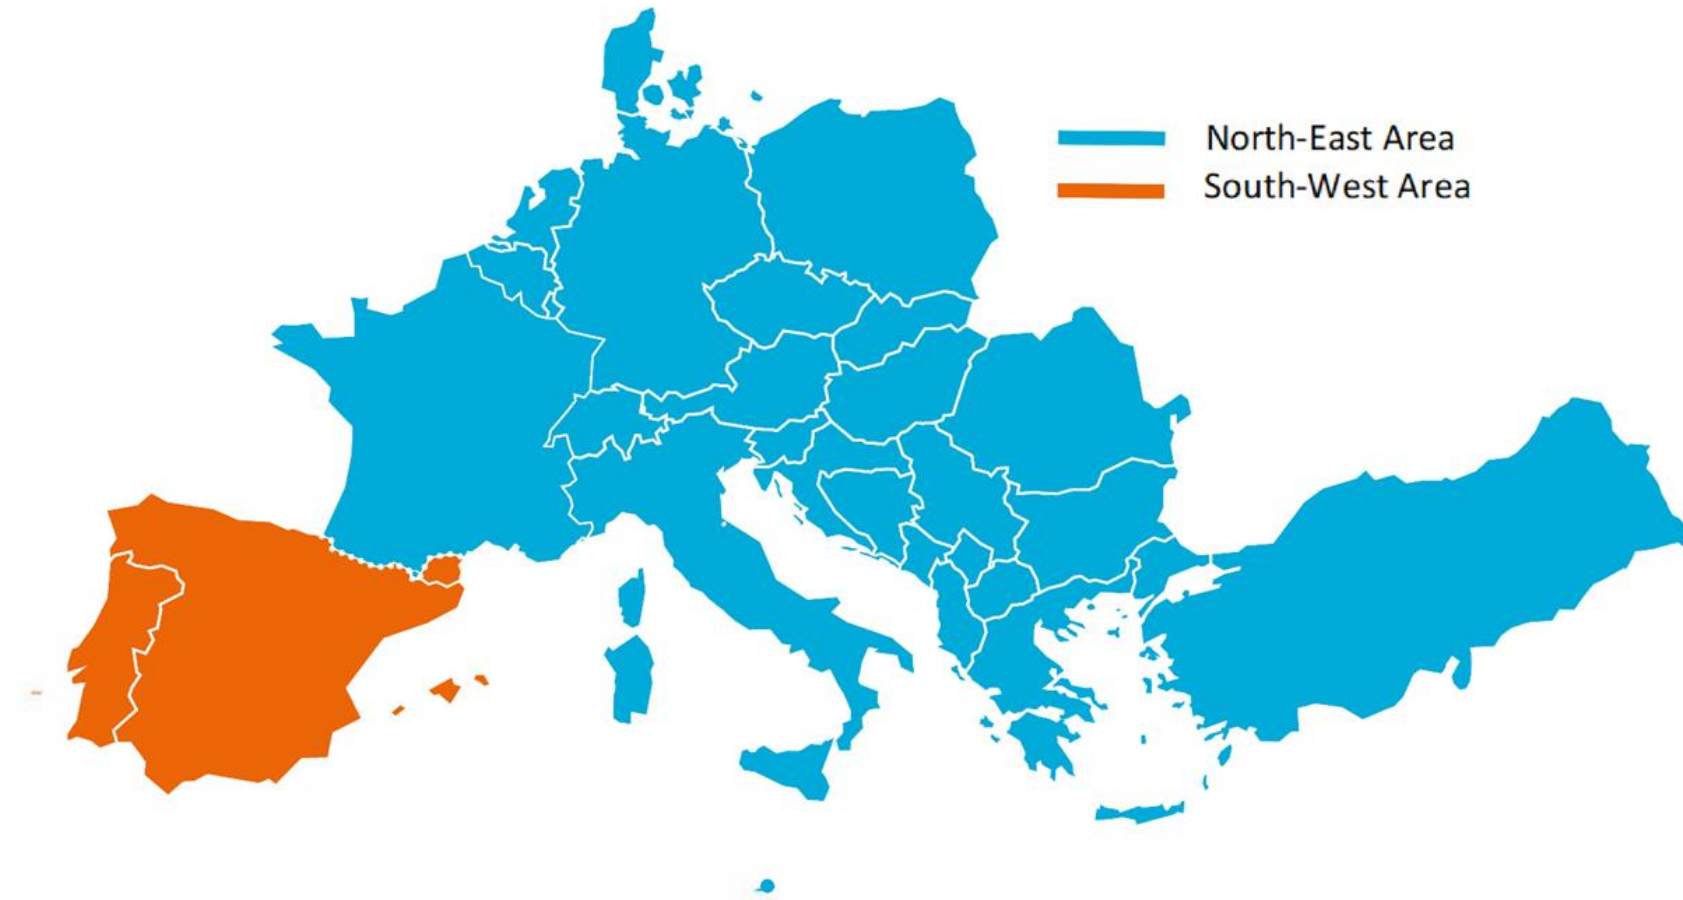
Rozdelenie CE 24.7.2021 na dve časti.

- Pred poruchou bol import do Španielska z Francúzska na úrovni 2500 MW
- Po poruche stúpila frekvencia vo väčšej časti CE na 50,06 Hz
- **V menšej časti Španielsko, Portugalsko, časť Francúzska) bol deficit elektriny a pokles frekvencie 48,65 Hz**
- Aktivované v Španielsku - frekvenčné odľahčovanie spotreby na úrovni 3561 MW
- Aktivované v Portugalsku – frekvenčné odľahčovanie záťaže na 680 MW
- Aktivované vo Francúzsku – frekvenčné odľahčovanie záťaže 65 MW

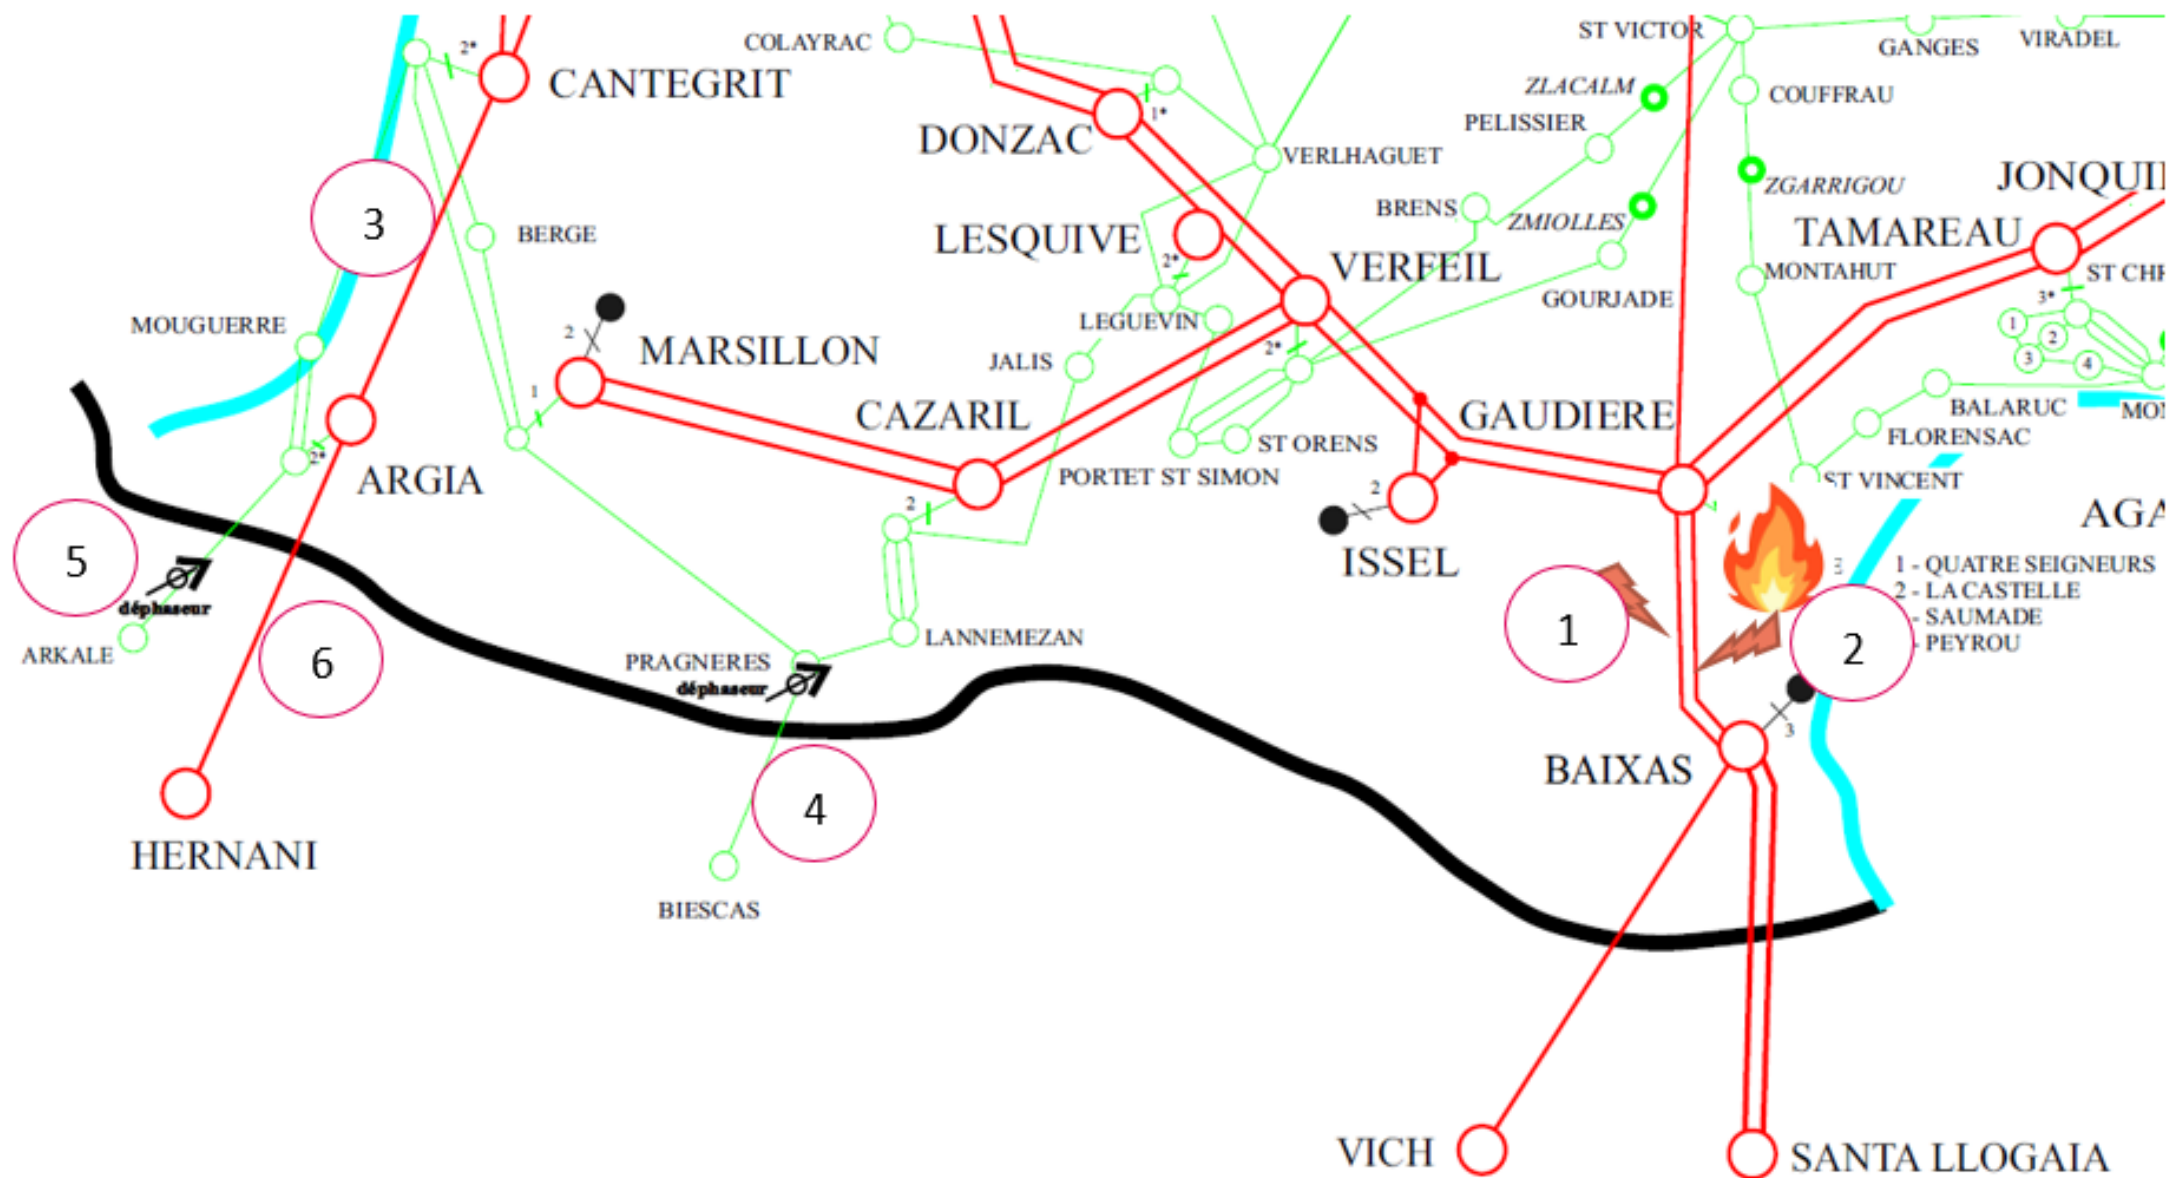
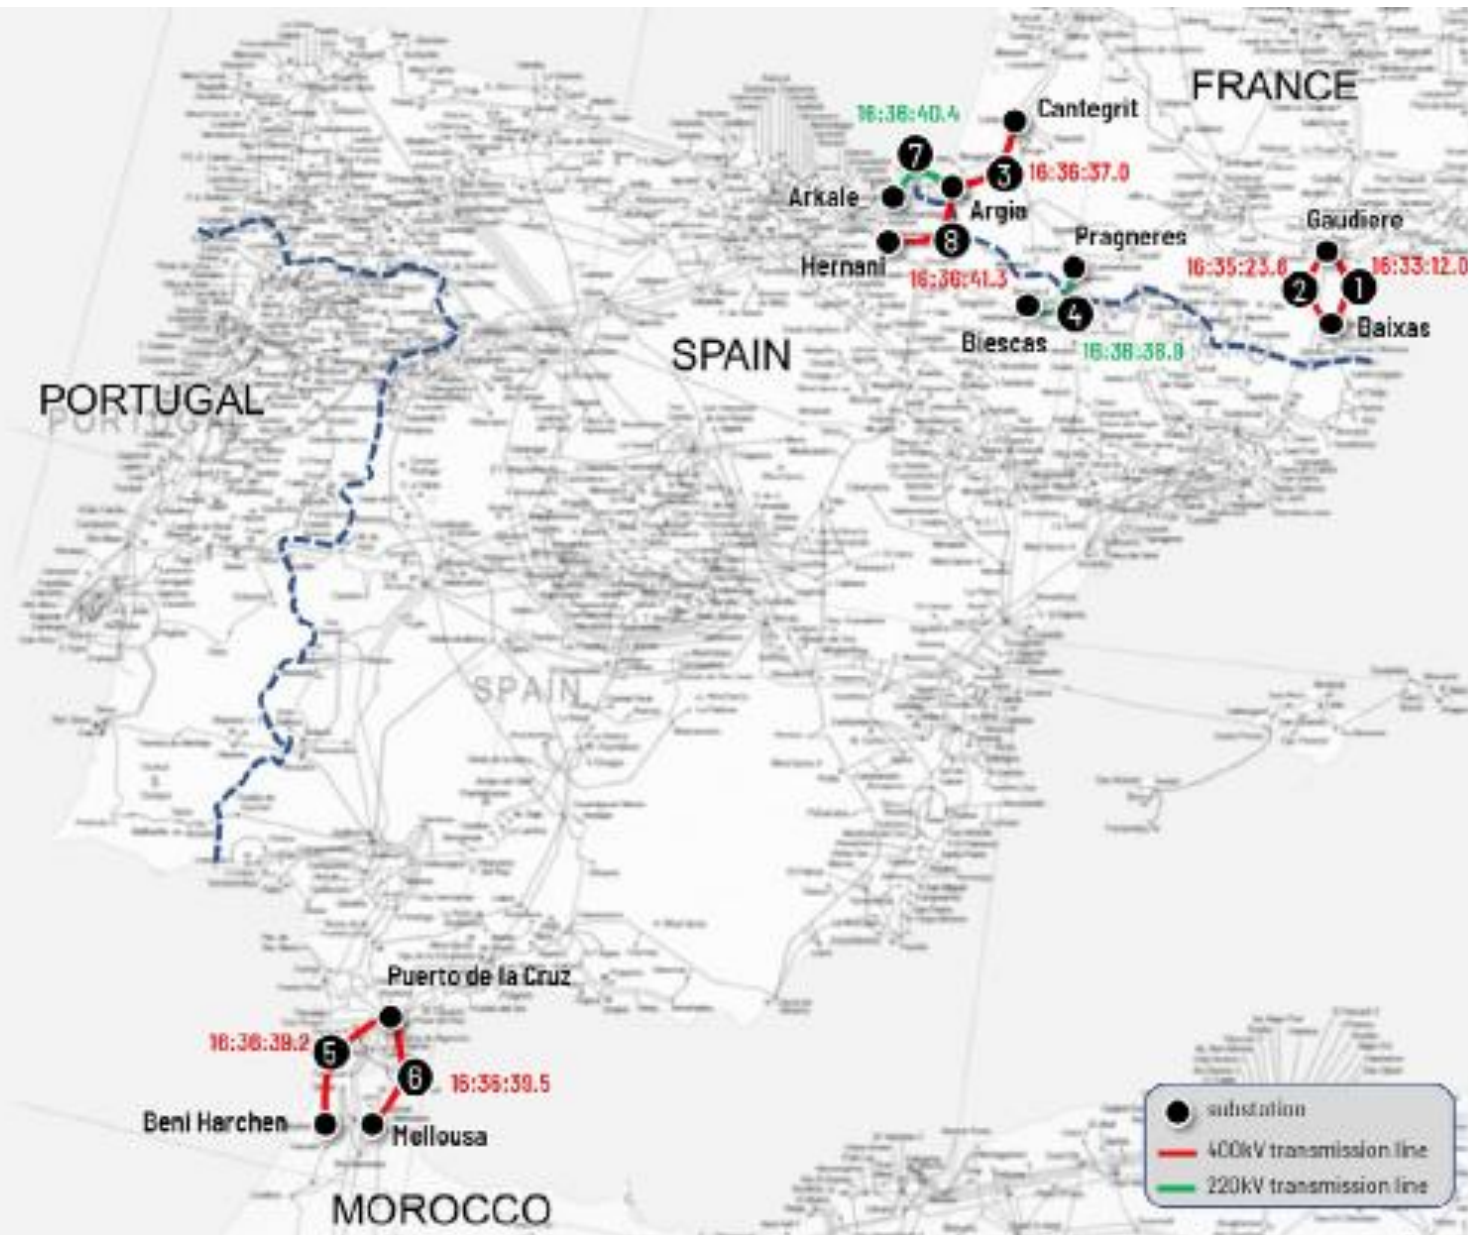
Priebeh poruchy

16:36 h. - kompletný rozpad profilu medzi Franzúzskom a Španielskom a to výpadok vedenia 400 kV Argia - Cantegrid **(3)**, 225 kV vedenia Pragneres - Biescas **(4)**, 225 kV vedenia Argia - Arkale **(5)** a finálne 400 kV vedenia Argia - Hernani **(6)**, k časti Španielska a Portugalska zostala pripojená aj malá časť Francúzska tzv. Pyrenees Orientales Region

Po poruche dispečingy REE a RTE vykonali množstvo koordinovaných opatrení, ktoré vyústili k resynchronizácii oboch oblastí CE už za 37 minút, t.j. o 17:09h. Odľahčená záťaž bola opätovne zapnutá v Portugalsku hodinu po incidente a v Španielsku o 18:38h.
